Tasmanian North East Rail Line

Assessment for Establishing a Heritage Rail Operation

Executive Summary

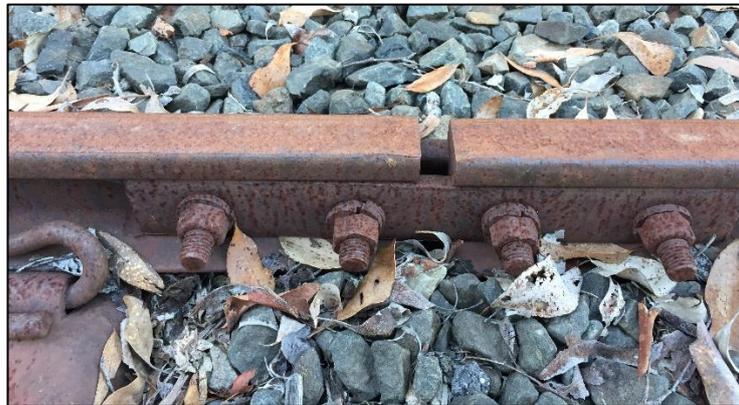
Figure 1. – Rusted fishplate

The rails on the line consist of nominal 30 kg/m rail and 40kg/m rail. The rails are generally in a satisfactory condition for carrying the rail car or the steam train. The rails are generally in short lengths with fish plated joints. All of the fish plated joints that were observed in the site inspection are rusted and appear to be frozen. Figure 1 below shows a picture of the rusted fishplates and figure 2 shows the area of concern.

- the bolts be removed by flame cutting
- the fish plates be removed
- the matching surfaces be wire brushed and lubricated with grease
- the fish plates be put back in place
- new bolts be inserted and tightened

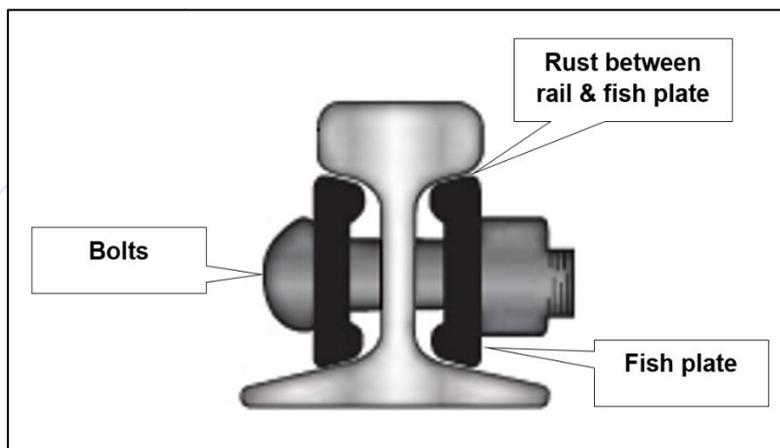
Figure 2. – Area of concern

This means the fish plates cannot be guaranteed to accommodate rail thermal expansion and contraction. The risk that this issue results in is track buckling which can cause derailments. In order to satisfactorily manage this risk it is suggested that:

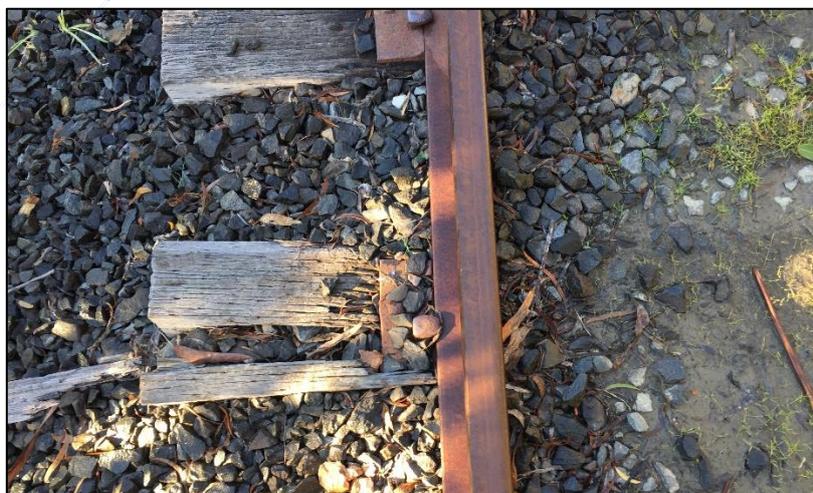
Figure 3. – Life expired sleeper

The timber sleepers have deteriorated with exposure to the elements. Figure 3 below shows a badly deteriorated sleeper which is reflective of a small percentage of sleepers, but many others are showing signs of rotting and splintering and also need replacement.

As part of the track rehabilitation, it will be necessary to replace some timber sleepers. The accepted practice on heritage railways, operating steam trains, is to have at least 1 in every 3 sleepers on straight track in good condition and capable of holding gauge. In other words capable of preventing the rails from moving outward under the load of the train. On curves, the practice is to have 1 in 2 sleepers capable of holding gauge and acting as bearers. The picture in figure 4 below shows the type of plant normally used during the partial resleepering process. This sleeper inserter mechanism can be mounted on a backhoe or small excavator. Figure 5 shows a typical small tamping machine that is used to tamp the replacement steel sleeper. This ensure ballast is well compacted under the steel sleeper thereby making it capable of carrying the forces applied under the load of a train.

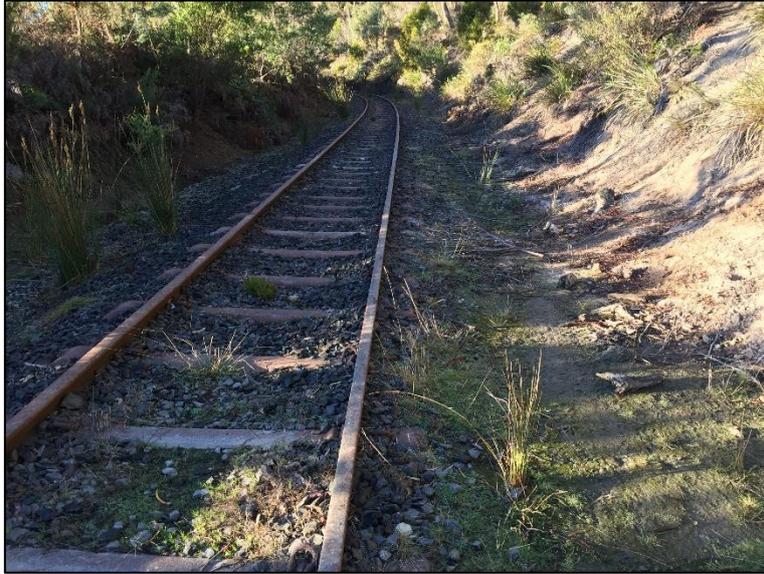
Figure 6. – Example of a silted cess drain

The track drainage system in some of the cuttings is not properly performing its function of carrying surface water away from the track structure. The badly silted drains need be cleaned out by removing the silt in accordance with standard practice. Figure 6 below shows a picture of a silted cess drain.

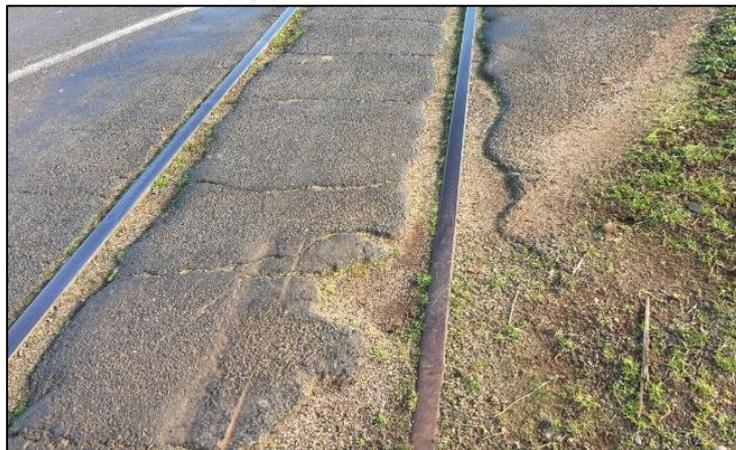
Figure 7. – Deteriorated level crossing at Scottsdale

The line to Scottsdale has a number of level crossings and the track beneath the crossing surface has not had any maintenance since at least the time train services were suspended. Figure 7 below shows the deteriorated level crossing at Scottsdale.

The practice on rail systems is to intermittently open the crossing and renew the track structure. The track within a crossing is prone to deterioration and the rails within the crossing are subject to an increased rate of corrosion. As an example of the risk associated with this issue, figure 8 shows

The level crossing track reconstruction involves removing the road surface material and track then rebuilding the track and reinstating the road surface. Figure 9 depicts the type of work involved in rebuilding the crossings after it has been opened up.

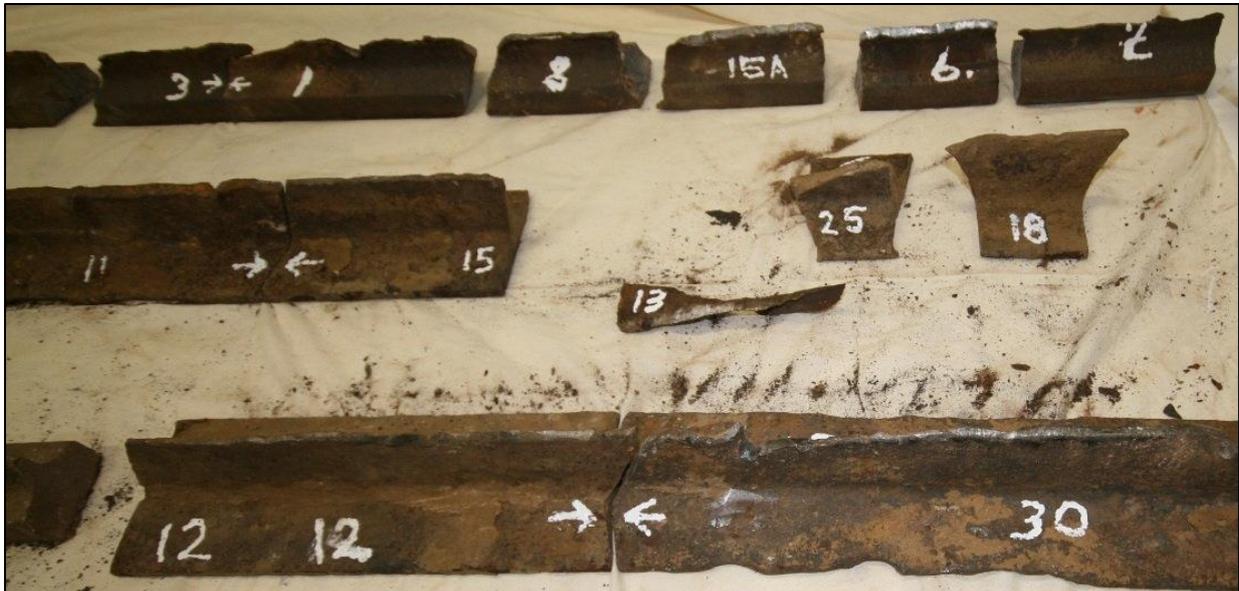
Figure 8. – Broken rusted rail taken from a crossing after the rail causing a derailment

a picture of a broken corroded rail taken from a crossing after the rail broke under a train causing a serious derailment.

It is recommended that L&NER's Safety Management System (SMS), when it is developed, should be written in a way that leads to level crossings on the North East line being opened up, inspected and rebuilt through the crossing unless it is found that the track is in good condition. Section six of this report provides more information about the Safety Management System.

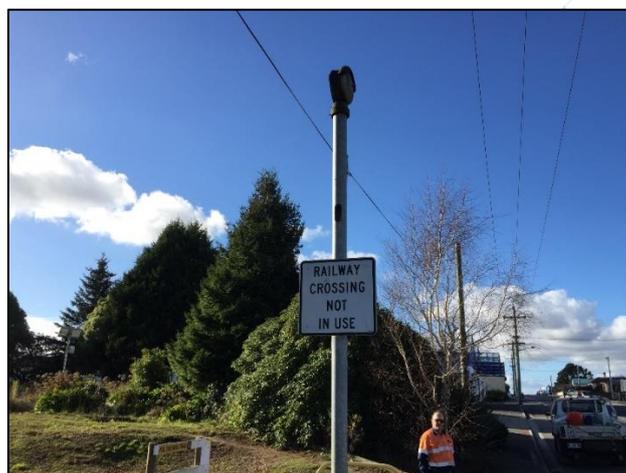
Figure 10. - Abandoned level crossing with only a post remaining

TasRail advises that between Turners Marsh and Scottsdale there were 10 level crossings that were protected by flashing lights, while L&NER itself suggest up to 15 actively controlled crossings may be required. Most of the level crossing protection system, including the bells and the equipment boxes, has been removed. This will mean an almost total rebuild of the system will be required prior to the reintroduction of train running. Figure 10 shows a picture of an abandoned level crossing at Scottsdale where all that remains of the protection system is the pole on which the bells used to be mounted.

It is likely that the yet to be developed SMS will recommend the level crossing protection system be reconstructed prior to reopening of the line to heritage trains. Unfortunately, the cost of rebuilding the level crossing protection is likely to be quite expensive, as new signalling equipment will probably be needed.

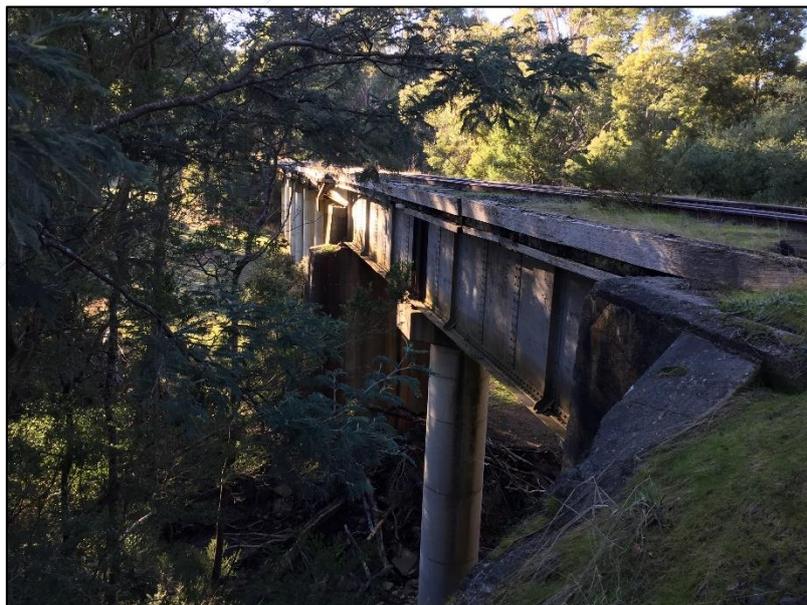
Figure 11. - Bridge at 13.5km - Karoola

The deck of this bridge is timber, the beams are steel and the abutments and piers are concrete. The bridge is in reasonable condition except for the timber deck. The deck is falling away in some places and requires replacement. Timber deck rotting occurs on many of the bridges and the picture below clearly shows the issue.

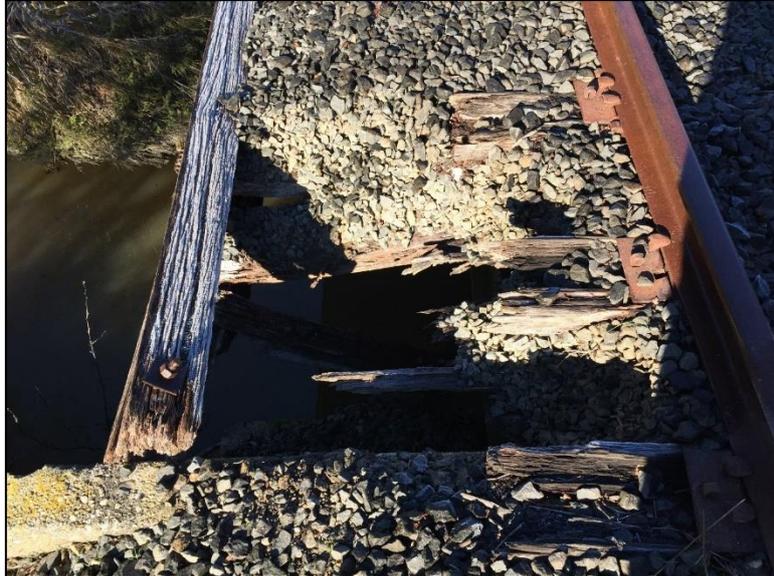
Figure 12. – Picture of a collapsing bridge deck - typical of many bridge decks on the North East line

This bridge has a single 8m metre span. The deck of this bridge is timber, the beams are steel and the abutments are concrete. The bridge is in reasonable condition except for the timber deck. The deck is generally falling away and requires replacement. The figure above shows a picture of the rotten deck on this bridge.

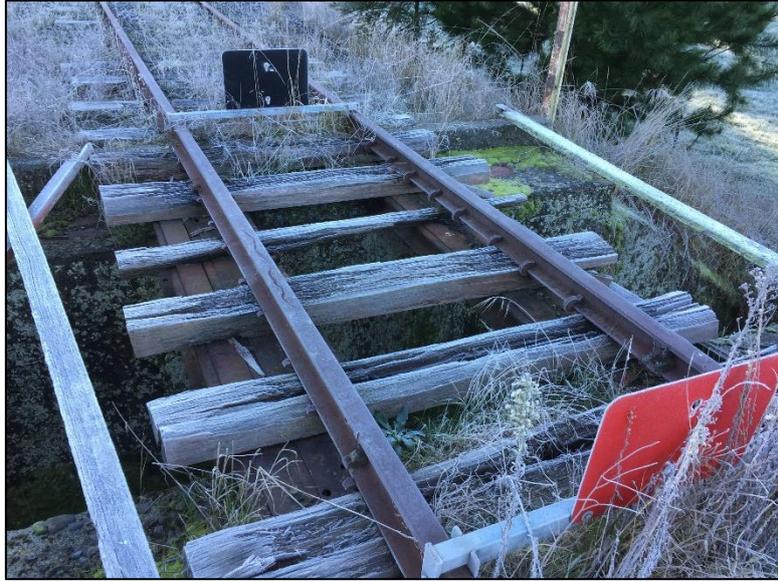
Figure 13. - Bridge at 23.6km

The bridge has an open deck, the beams are steel and the abutments are concrete. The bridge is in reasonable condition except for the transoms (sleepers that have been machined to a uniform depth). The transoms require replacing before trains commence operation.

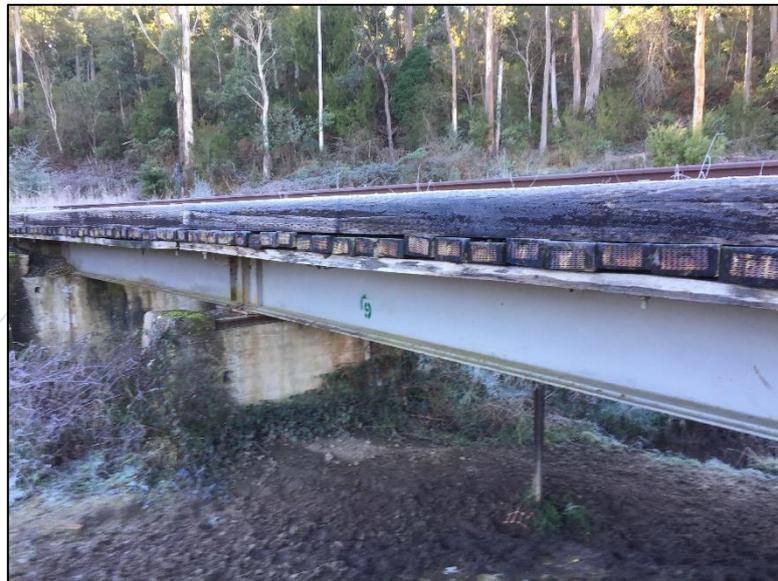
Figure 14. - Bridge at 23.85km

The deck of this bridge is timber, the beams are steel and the abutments and piers are concrete. The bridge is in reasonable condition including the timber deck.

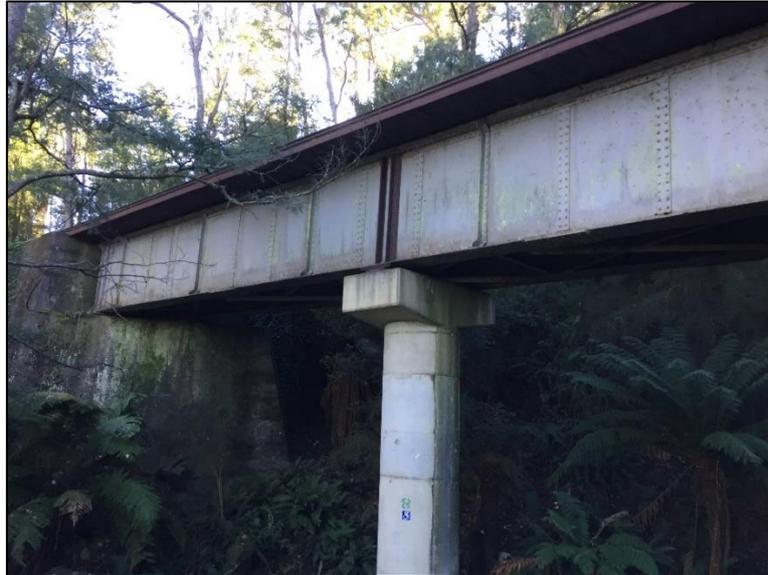
Figure 15. - Bridge at 24.2km

The deck of this bridge is steel rails. The beams are steel and the abutments and piers are concrete. The bridge is in reasonable overall condition.

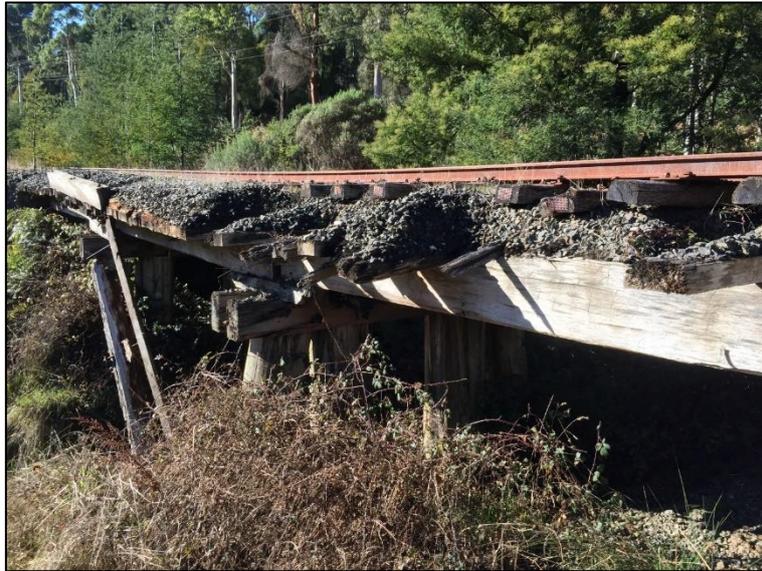
Figure 15. - Bridge at 37.75km

As can be seen in the photo, this bridge is built entirely of timber. It is collapsing and requires total replacement.

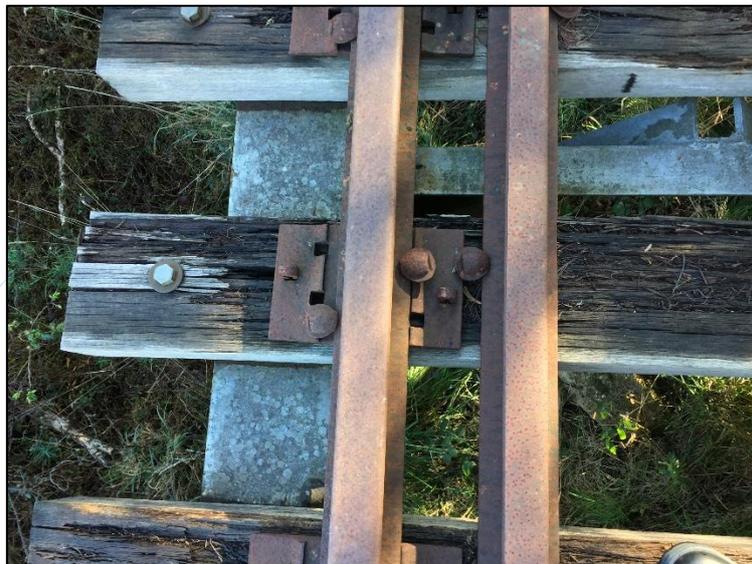
Figure 16. - Bridge at 45.8km

The bridge has an open deck, the beams are steel and the abutments and piers are concrete. The bridge is in reasonable condition except for the transoms, which require relacing before trains commence operation.

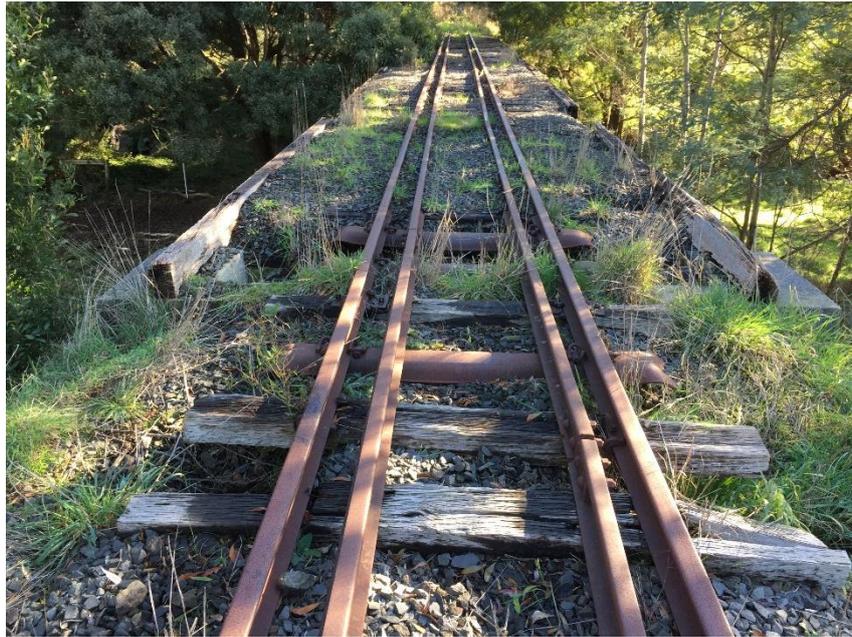
Figure 17. - Bridge at 47.65km

The deck of this bridge is timber, the beams are steel and the abutments and piers are concrete. The bridge is in reasonable condition except for the timber deck. The deck is falling away in some places and requires replacement.

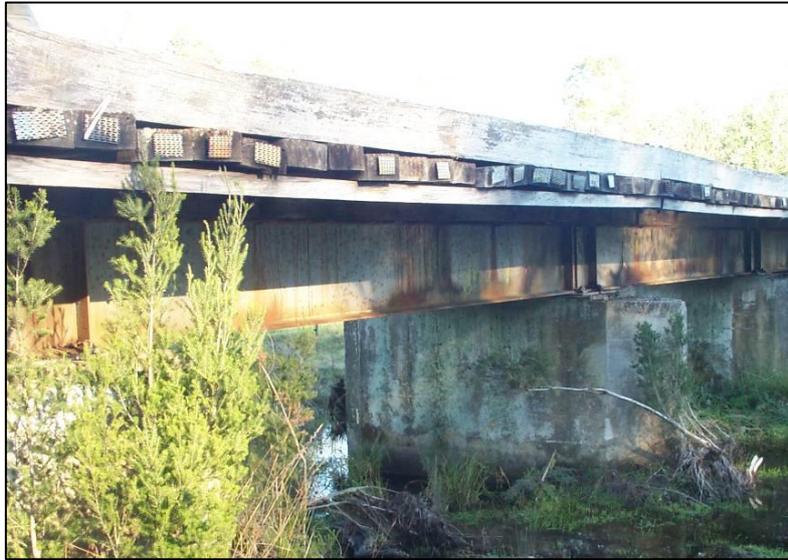
Figure 18. - Bridge at 47.8km

The deck of this bridge is timber, the beams are steel and the abutments and piers are concrete. The bridge is in reasonable condition throughout.

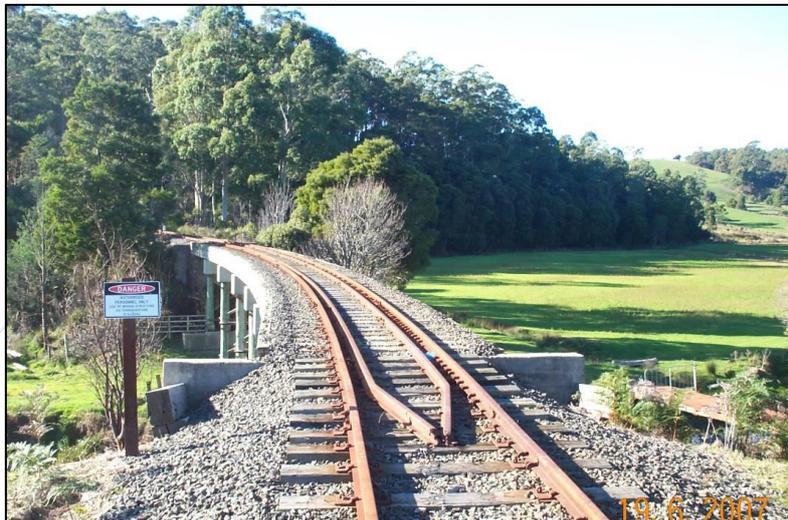
Figure 19. - Bridge at 58.5km

The deck of this bridge is concrete, the beams and abutments are concrete while the piers are timber. TasRail advises that this bridge was rebuilt not long before the line was closed to trains and therefore the bridge is generally in good condition. The piers on this bridge are timber which should be subject to a more detailed examination before trains are allowed to run again. This would include drilling the piers to look at soundness.

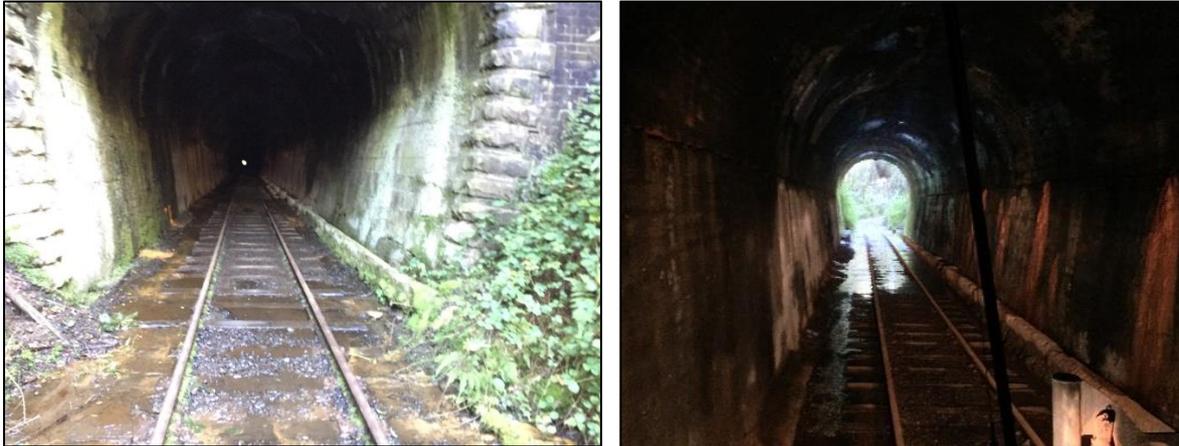
The tunnel appears to be generally in reasonable condition apart from drainage issues as can be seen in the pictures below taken at both ends of the tunnel.

Figure 20. – Pictures of tunnel showing failed drainage system and flooded track

It is not acceptable to have water sitting on the track up to the top of the sleepers. The tunnel drainage system needs to be rectified. It is suggested that the drains in the tunnel, and the cuttings at either end, should be dug out and have pipes installed on both sides of the track.

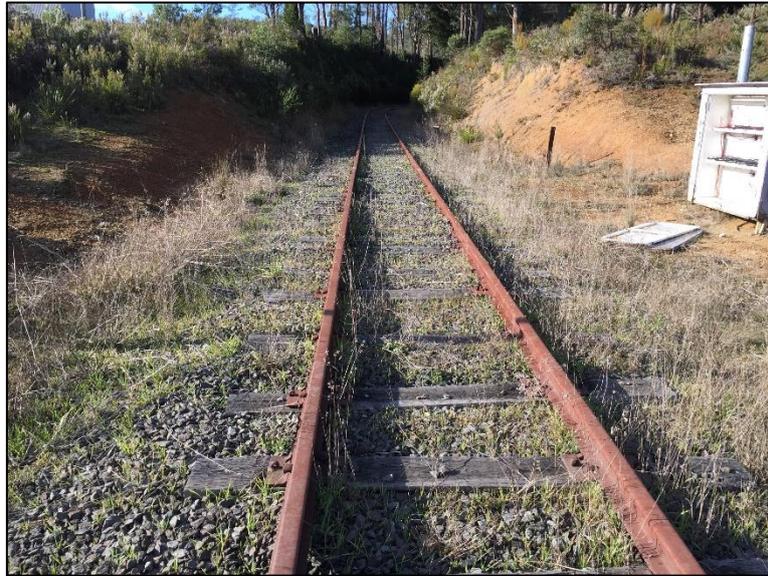
Some of the open track drains (cess trains) have become silted over the years and will require cleaning out to ensure the rehabilitated track is well drained. Figure 21 below shows a typical silted malfunctioning open cess drain.

Figure 21. – Picture of silted cess drains

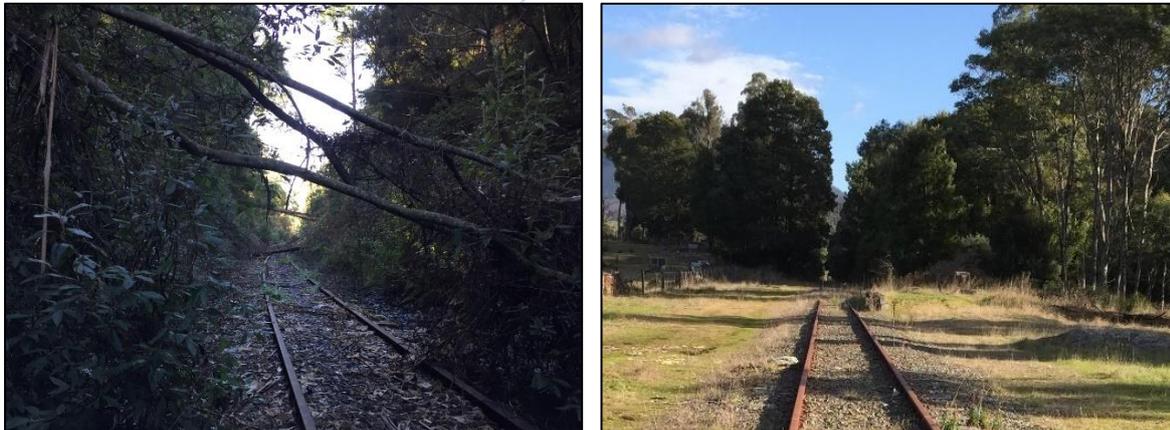
In a number of locations, it will be necessary to cut back trees and bushes that have grown close to the line. This will be particularly needed for the operation of a steam train because of the risk of fires starting from sparks. The pictures below show two locations where vegetation will be a problem.

Figure 22. – Examples of areas requiring vegetation clearing
