**Department of Infrastructure,
Energy & Resources**

Main Road Transit Corridor

Pedestrian Access
Assessment

Stage 1 – Issues Paper

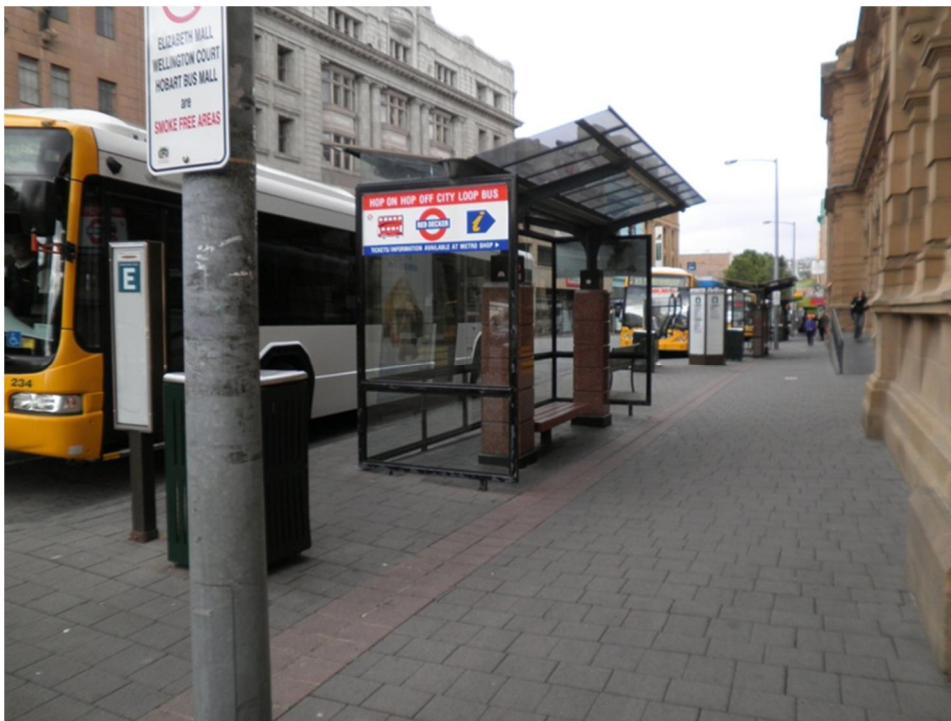
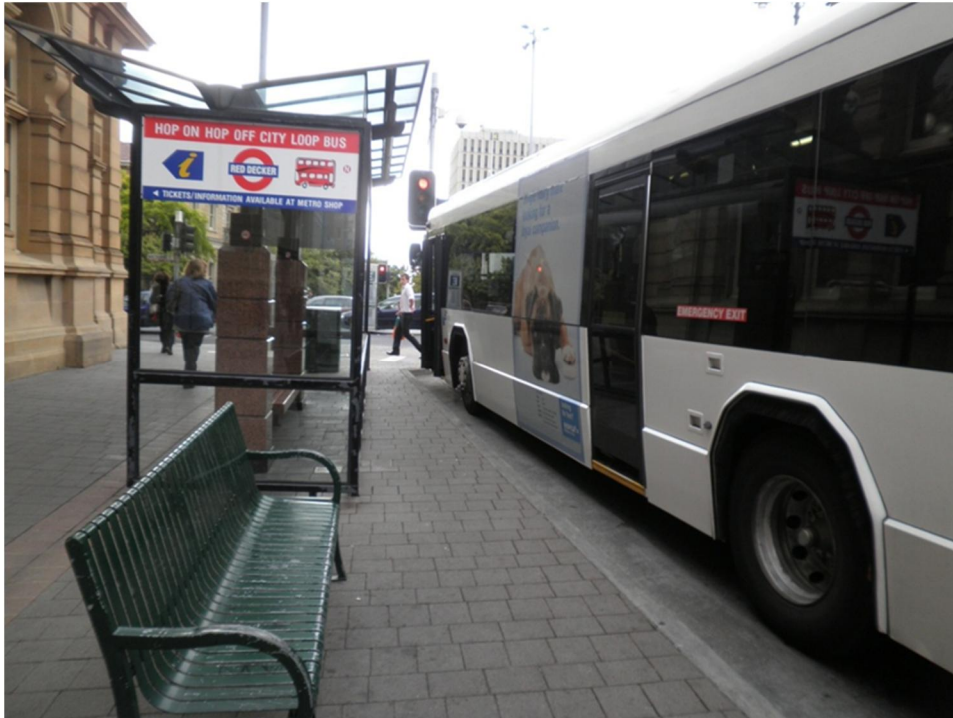
Figure 1 Elizabeth Street Bus Mall – Outbound (Facing North)

Figure 2 Elizabeth Street Bus Mall - Outbound (Facing South)

Characteristic	Description
Bus Stop	<ul style="list-style-type: none"> • signs are non-standard • static timetables • no route or locality maps are on display
Footpath	<ul style="list-style-type: none"> • paved • approx. 2 m wide • width varies due to building line and placement of other shelters within bus mall • tactile surface indicators on pram ramps
Pedestrian Crossings	<ul style="list-style-type: none"> • signalised pedestrian crossings located at traffic lights at both ends of the mall
Safety	<ul style="list-style-type: none"> • CCTV cameras located at both ends of mall • high level of pedestrian activity occurs near the bus stop
Lighting	<ul style="list-style-type: none"> • street lighting located along the length of the mall
Pay phone	<ul style="list-style-type: none"> • 2 located on opposite side of mall
Shelter	<ul style="list-style-type: none"> • enclosed glass shelter • faces away from the street

Characteristic	Description
Seating	<ul style="list-style-type: none">• wooden bench seat• waiting passengers also sit on steps outside Post Office
Access	<ul style="list-style-type: none">• limited to buses, taxis, service vehicles and cyclists

- ▶ Lack of route or locality maps available at this main stop (although there is a Metro Shop on the opposite side of the bus mall where passengers can seek information during business hours);
- ▶ Unused space on the road side of the bus shelters;
- ▶ View of oncoming buses when sitting in the shelters facing buildings is restricted mainly by the wide shelter pillar supports;
- ▶ Queuing arrangement is unclear for passengers waiting to board;
- ▶ Congestion associated with through pedestrian traffic and waiting passengers; and
- ▶ Difficulty for buses moving from Stop E into the traffic stream and turning around corner, especially when other buses are departing mall. Buses experience delay when turning left and right from mall as they need to give way to pedestrians using the signalised crossings.

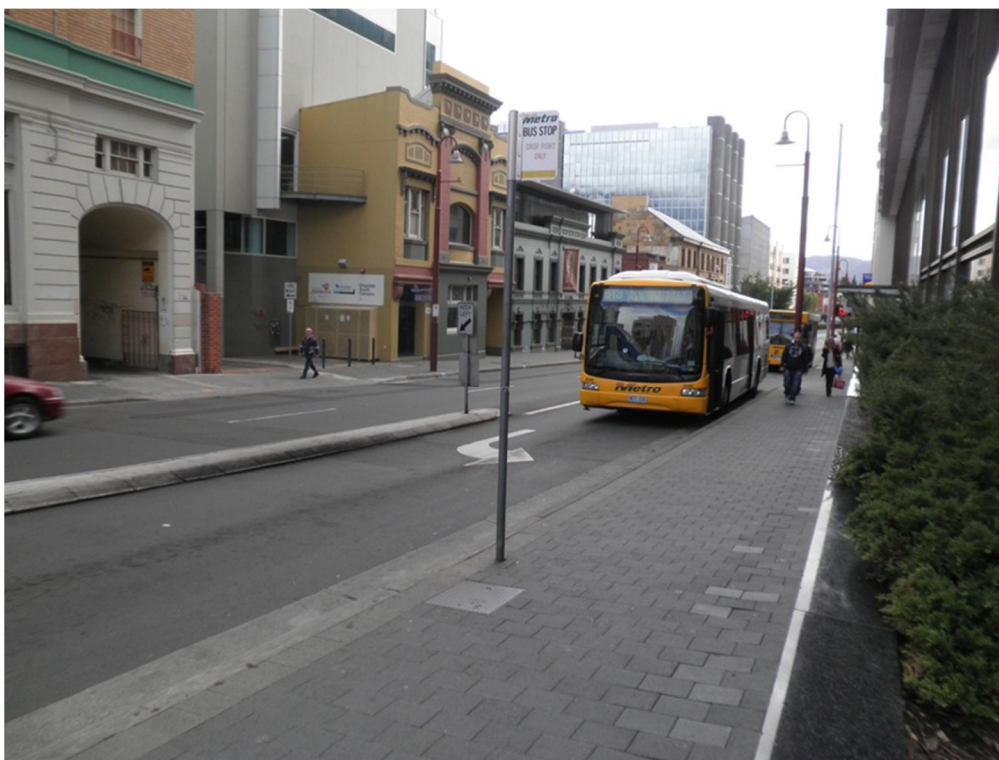
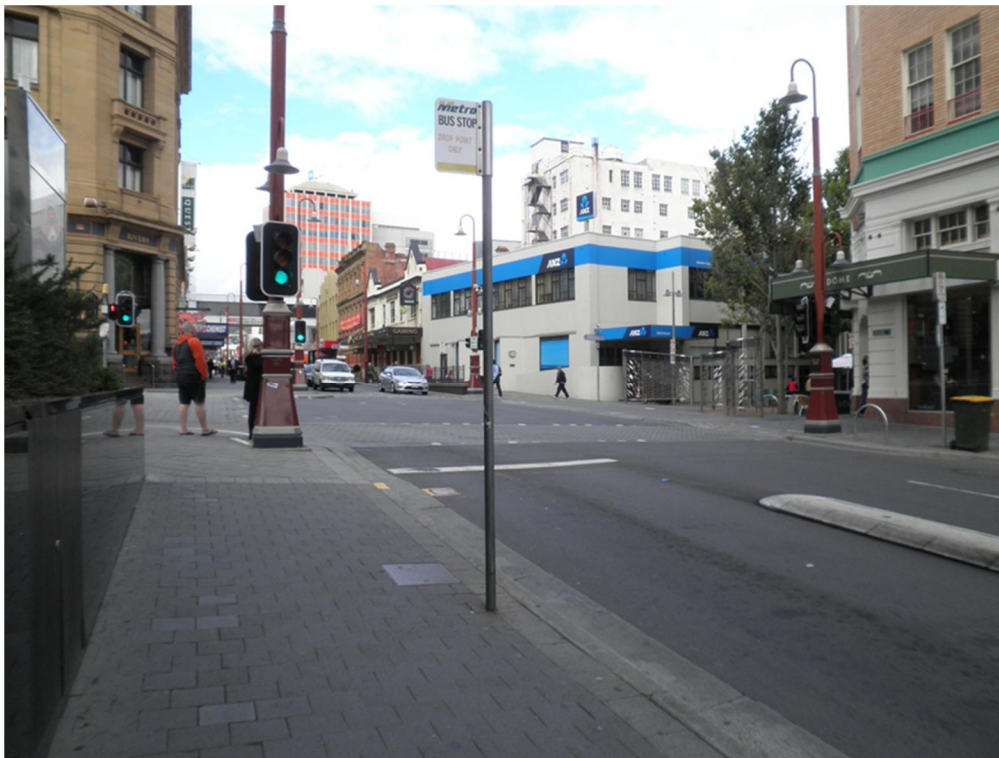
Figure 3 Collins Street Drop Off – Inbound (Facing East)

Figure 4 Collins Street Drop Off – Inbound (Facing West)

Characteristic	Description
Footpath	<ul style="list-style-type: none"> • paved • slight gradient • approx. 2 m wide • width varies due to building line and placement of other shelters with bus mall • normal kerb height
Safety	<ul style="list-style-type: none"> • passive • good due to high levels of pedestrian activity and the Collins Street taxi rank situated diagonally opposite • CCTV cameras located above the stop
Lighting	<ul style="list-style-type: none"> • street lighting
Shelter	<ul style="list-style-type: none"> • not required due to drop off only nature of the stop
Seating	<ul style="list-style-type: none"> • not required due to drop off only nature of the stop
Pay phone	<ul style="list-style-type: none"> • located nearby in mall

- ▶ Buses drop passengers off directly onto footpath which causes congestion with through pedestrians.
- ▶ Second bus alights in front of a building with a revolving door which causes pedestrian conflicts.

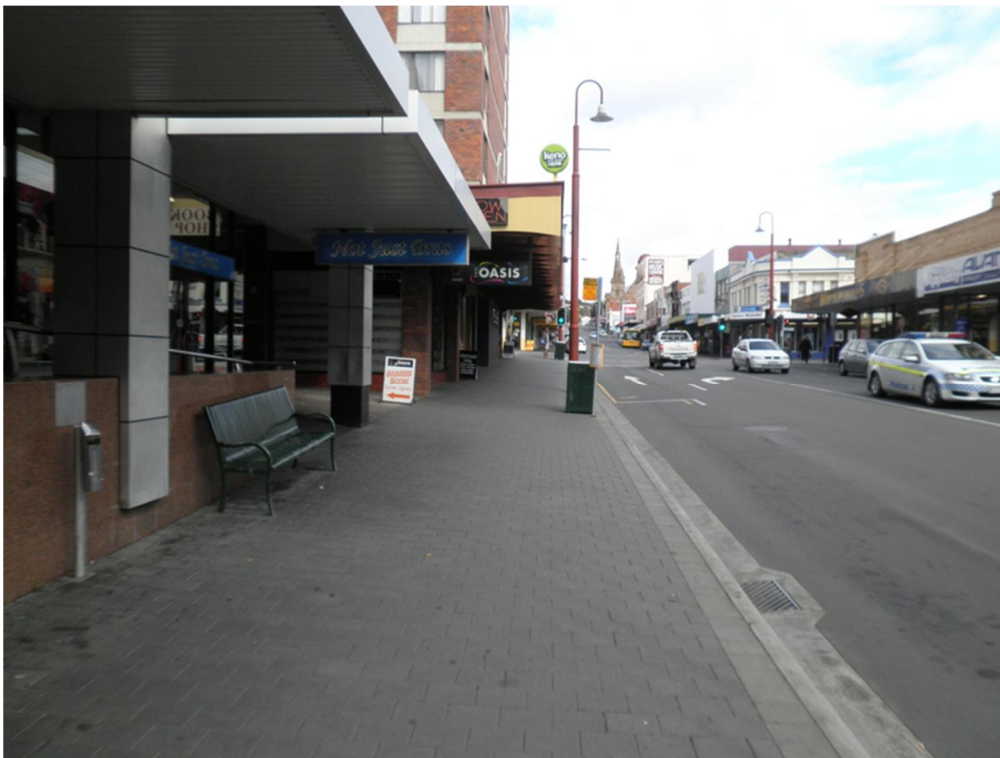
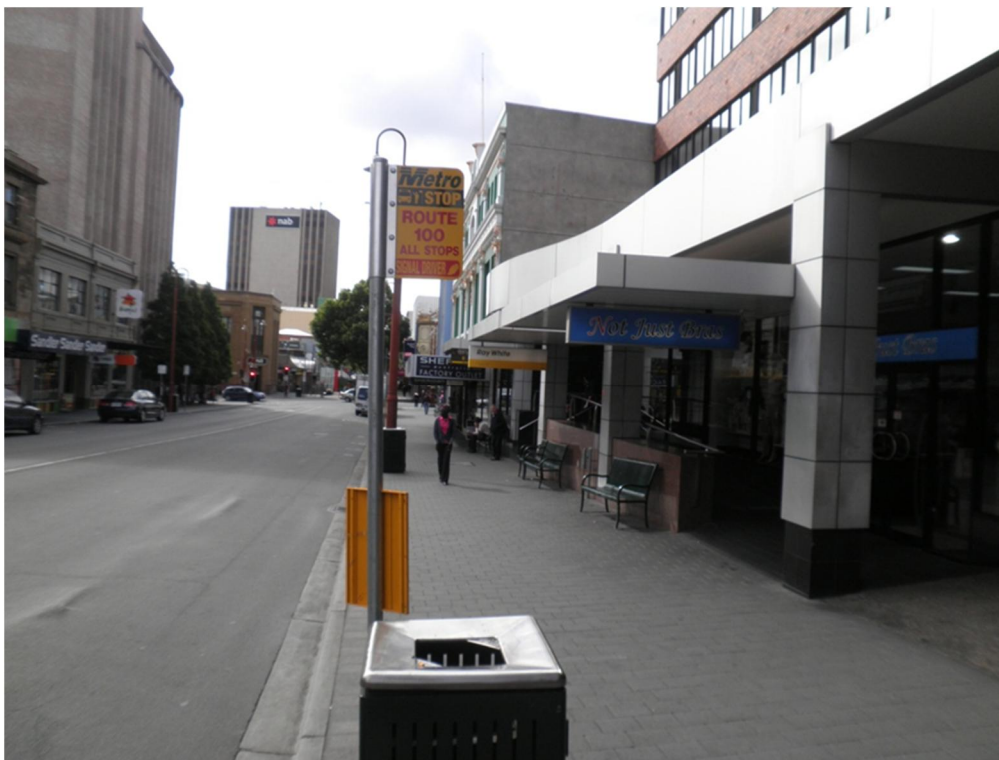
Figure 5 Between Liverpool and Bathurst Street – Outbound (Facing North)

Figure 6 Between Liverpool and Bathurst Street – Outbound (Facing South)

Characteristic	Description
Bus Stop	<ul style="list-style-type: none"> • static timetables provided • no route or locality maps are on display • no tactile surface indicators • located in main shopping area
Footpath	<ul style="list-style-type: none"> • paved • approx. 4 m wide • slight crossfall • kerb is lower than standard at approx. 100 mm, which increases the step height when boarding bus
Pedestrian Crossings	<ul style="list-style-type: none"> • signalised crossings at each of the nearby intersections
Safety	<ul style="list-style-type: none"> • high level pedestrian activity
Lighting	<ul style="list-style-type: none"> • street lighting • provided by shop awnings • adjacent alley way poorly lit during the day
Shelter	<ul style="list-style-type: none"> • provided by irregular shop awnings

Characteristic	Description
Seating	<ul style="list-style-type: none">• 3 benches• 2 single seats
Visibility	<ul style="list-style-type: none">• good view of oncoming buses• difficult to identify location of stop when looking from Mall

- ▶ During the day the adjacent alley way is poorly lit and may be a safety / security issue;
- ▶ The kerb is lower than standard which may make it harder for some passengers to step up onto a bus;
- ▶ Queuing of passengers can cause congestion with through pedestrian traffic;
- ▶ The bus stop sign information is misleading as it reads 'Route 100 All Stops' however not all buses are Route 100; and
- ▶ The bus stop is not easily identifiable from the Elizabeth Street mall.

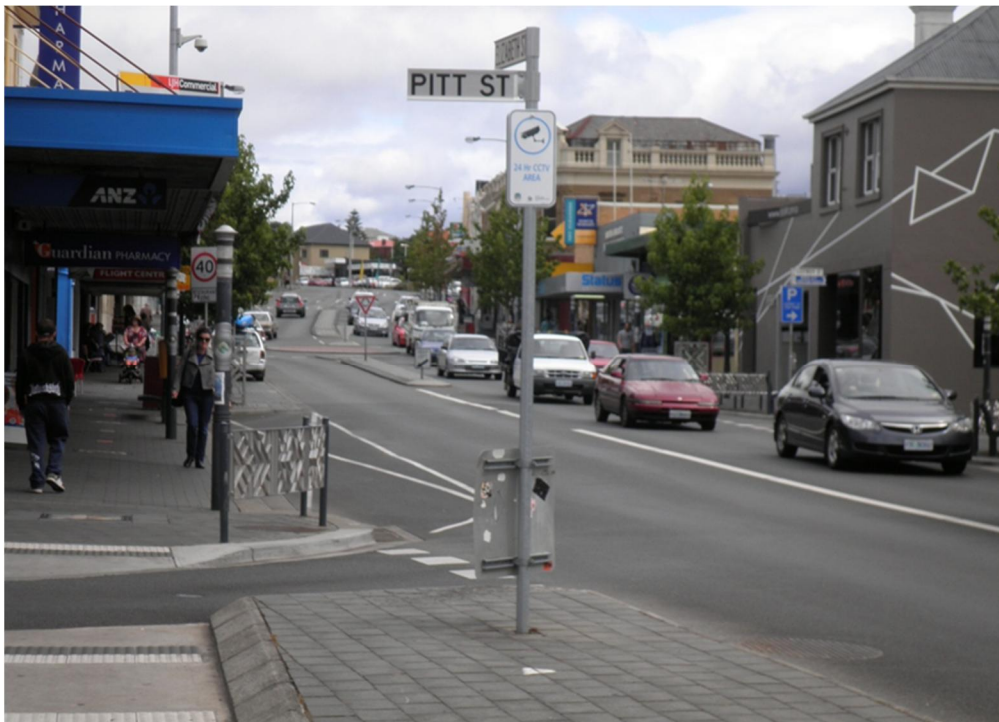
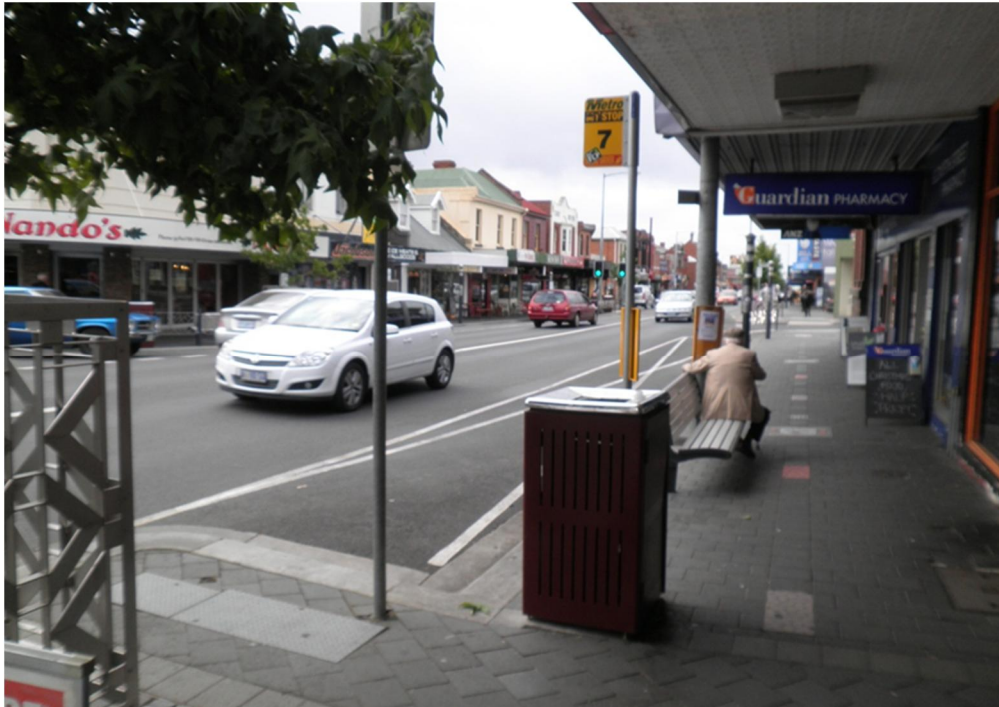
Figure 7 North Hobart – Outbound (Facing North)

Figure 8 North Hobart – Outbound (Facing South)

Characteristic	Description
Bus Stop	<ul style="list-style-type: none"> static timetables no route or locality maps are on display signage can be obstructed by surrounding signage and awnings
Footpath	<ul style="list-style-type: none"> paved approx. 3 m wide lower than standard at approx. 100 mm pavement markings highlights bus stop for motorists tactile surfaces on pram ramps at signalised crossing
Safety	<ul style="list-style-type: none"> CCTV cameras present above awning view of stop is most likely obstructed by awning high vehicle and pedestrian traffic creates high passive surveillance
Lighting	<ul style="list-style-type: none"> street lighting provided by shop awnings
Pay phone	<ul style="list-style-type: none"> 30 m away
Shelter	<ul style="list-style-type: none"> provided by shop awnings
Seating	<ul style="list-style-type: none"> one bench facing shops

Characteristic	Description
Access	<ul style="list-style-type: none">• connectivity to surrounds is good
Visibility	<ul style="list-style-type: none">• clear

- ▶ There is only one bench seat that is well utilised which faces shops making it harder to see oncoming buses;
- ▶ Advertising boards take up space on footpath which causes extra congestion with queuing passengers and through pedestrians;
- ▶ The kerb is lower than standard which may make it harder for some passengers to step up onto a bus;
- ▶ The bus stop sign is obstructed by awnings; and
- ▶ Buses stop a few meters back from sign due to obstacles including the street light pole and bench seat, as well as difficulty negotiating around a kerb blister back into the traffic stream.

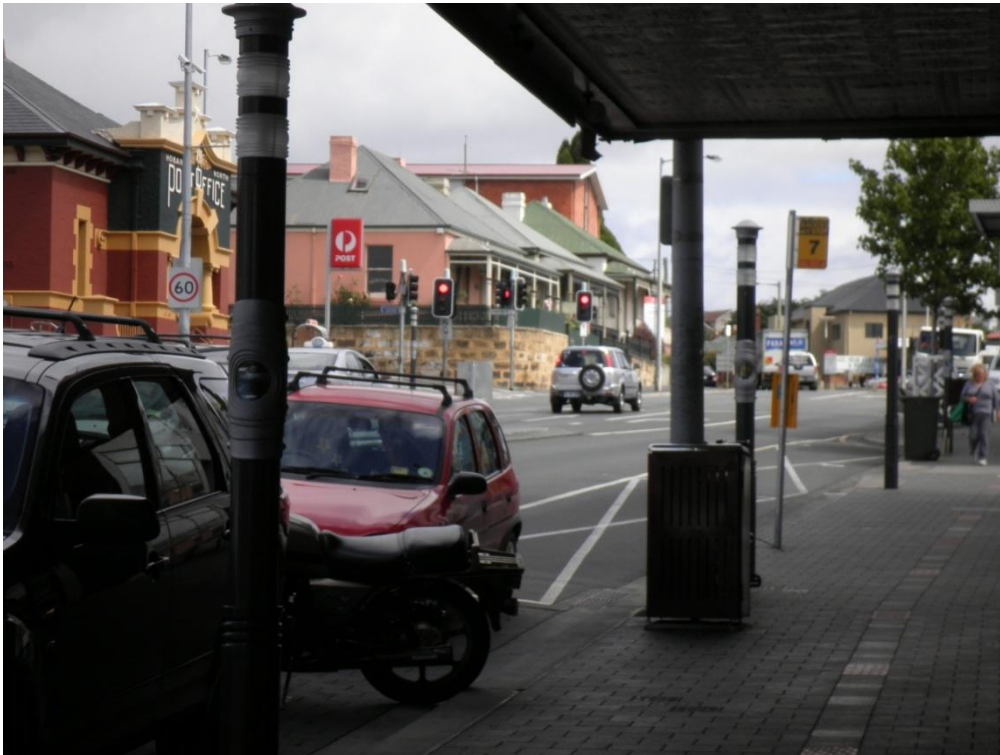
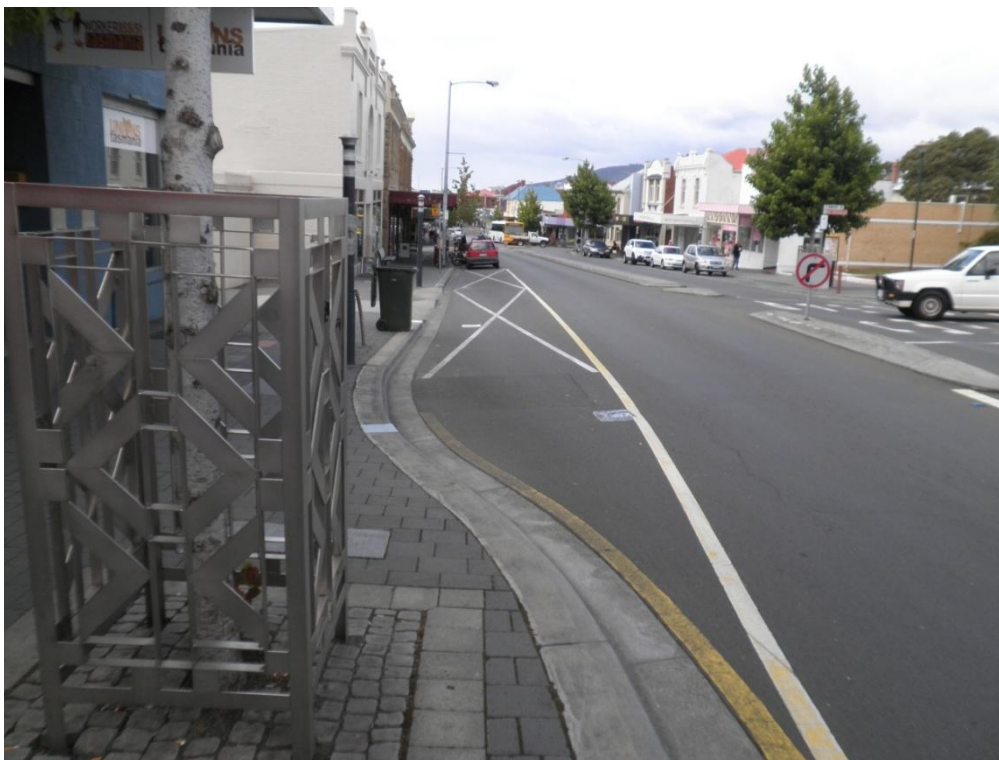
Figure 9 North Hobart – Inbound (Facing North)

Figure 10 North Hobart - Inbound (Facing South)

Characteristic	Description
Bus Stop	<ul style="list-style-type: none"> static timetables no route or locality maps are on display visible with the standard yellow sign and pavement paint markings
Footpath	<ul style="list-style-type: none"> paved approx. 3 m wide with a slight crossfall kerb is lower than standard at approx. 100 mm
Pedestrian Crossings	<ul style="list-style-type: none"> located approx. 20 m north of stop at the signalised intersection
Safety	<ul style="list-style-type: none"> no CCTV cameras in area high vehicle through traffic and moderate pedestrian activity provides passive surveillance Stop is located outside state cinema
Lighting	<ul style="list-style-type: none"> illumination provided by street lighting
Pay phone	<ul style="list-style-type: none"> 30 m away across road
Shelter	<ul style="list-style-type: none"> no shelter directly above stop or seating

Characteristic	Description
	<ul style="list-style-type: none">• there are adjacent shop awnings
Seating	<ul style="list-style-type: none">• 1 bench seat on the building side of footpath facing road
Bike storage	<ul style="list-style-type: none">• bike hoops nearby
Access	<ul style="list-style-type: none">• a 'Guide to Hobart' including map is located directly across the road from stop• connectivity to surrounds is good
Visibility	<ul style="list-style-type: none">• roads is straight• good view of oncoming buses• may be hard to see from further into North Hobart strip

- ▶ There is no shelter directly at the stop and over the provided seating;
- ▶ The stop may be hard to identify from further into the North Hobart strip;
- ▶ Buses may have trouble re-entering traffic stream due to congestion on approach to Newdegate Street roundabout;
- ▶ Driveway at rear of stop may be temporarily obstructed by stopping buses;
- ▶ The kerb is lower than standard which may make it harder for some passengers to step up onto a bus.

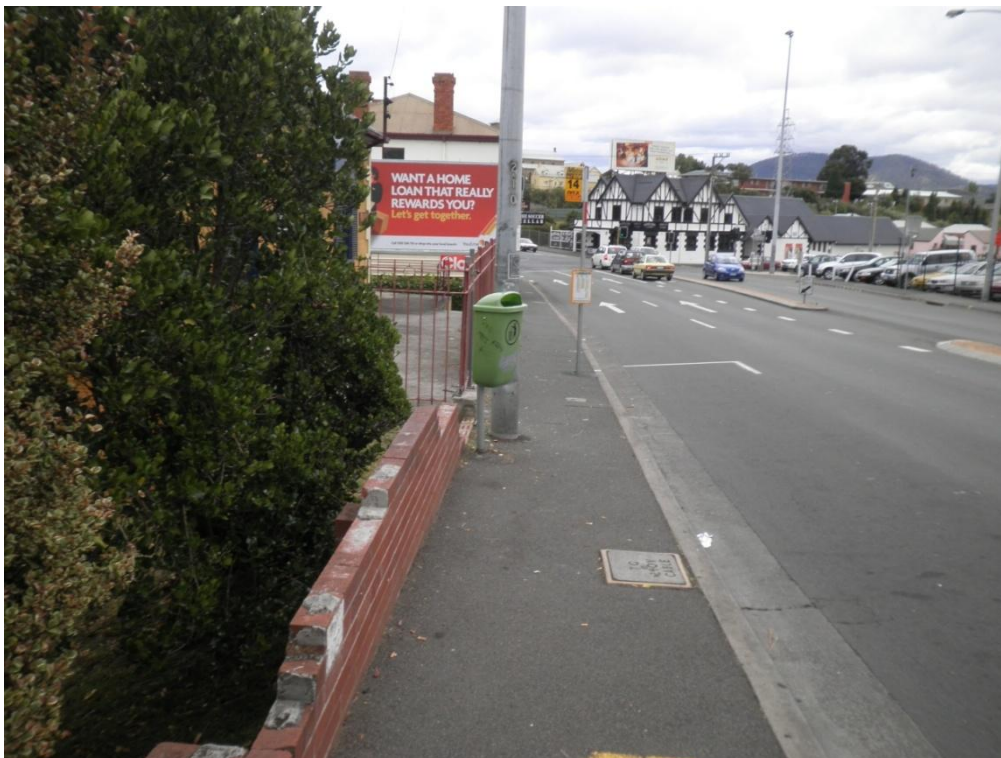
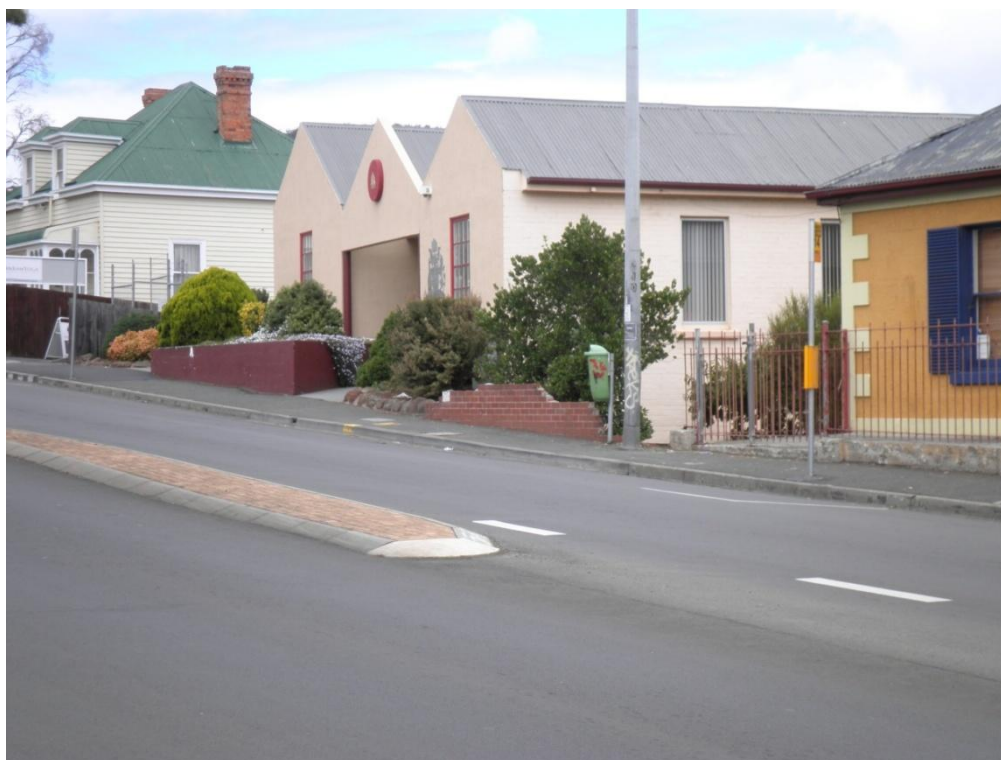
Figure 11 New Town – Outbound (Facing North)

Figure 12 New Town – Outbound (Facing South)

Characteristic	Description
Bus Stop	<ul style="list-style-type: none"> • static timetables • no route or locality maps are on display
Footpath	<ul style="list-style-type: none"> • asphalt • approx. 2 m wide • standard height kerb • slight gradient
Pedestrian Crossings	<ul style="list-style-type: none"> • narrow median island on road • pedestrian crossing approx. 30 m north of stop at a signalised intersection
Safety	<ul style="list-style-type: none"> • no CCTV cameras in area • moderate pedestrian activity • high vehicle through traffic
Lighting	<ul style="list-style-type: none"> • illumination provided by street lighting
Shelter	<ul style="list-style-type: none"> • none
Seating	<ul style="list-style-type: none"> • none

- ▶ There is no seating or shelter available in the vicinity of the stop;
- ▶ Street light post and bin are obstacles that further narrow the footpath at the bus stop;
- ▶ Pedestrians waiting causes congestion on the narrow footpath; and
- ▶ There are no way-finding measures and the stop may be hard to find from New Town Plaza.

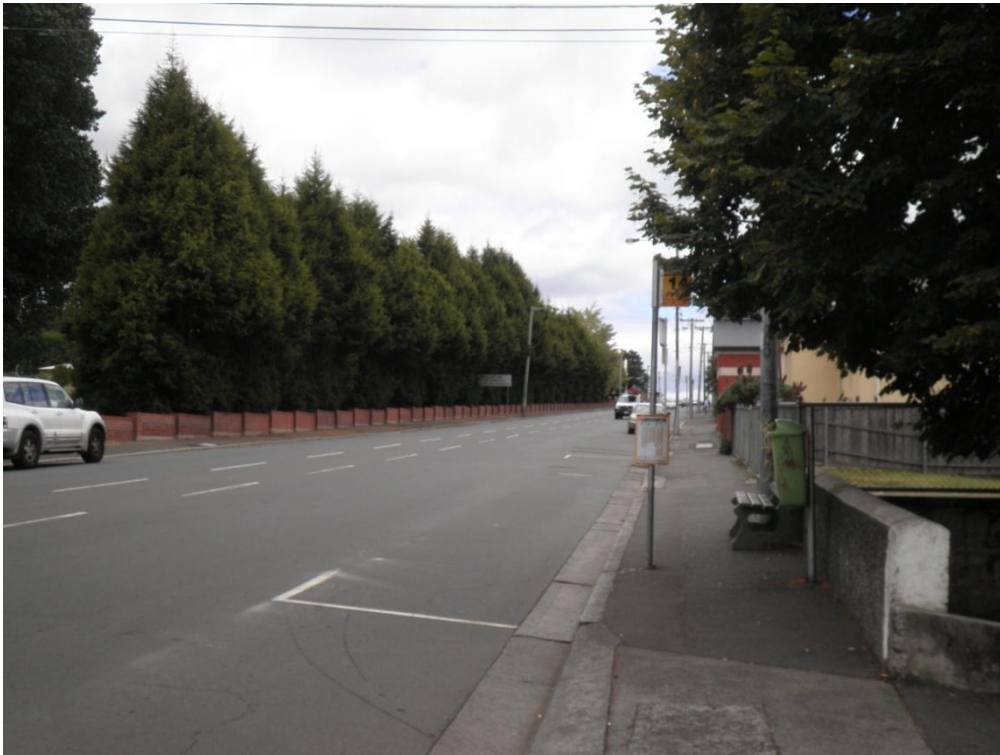
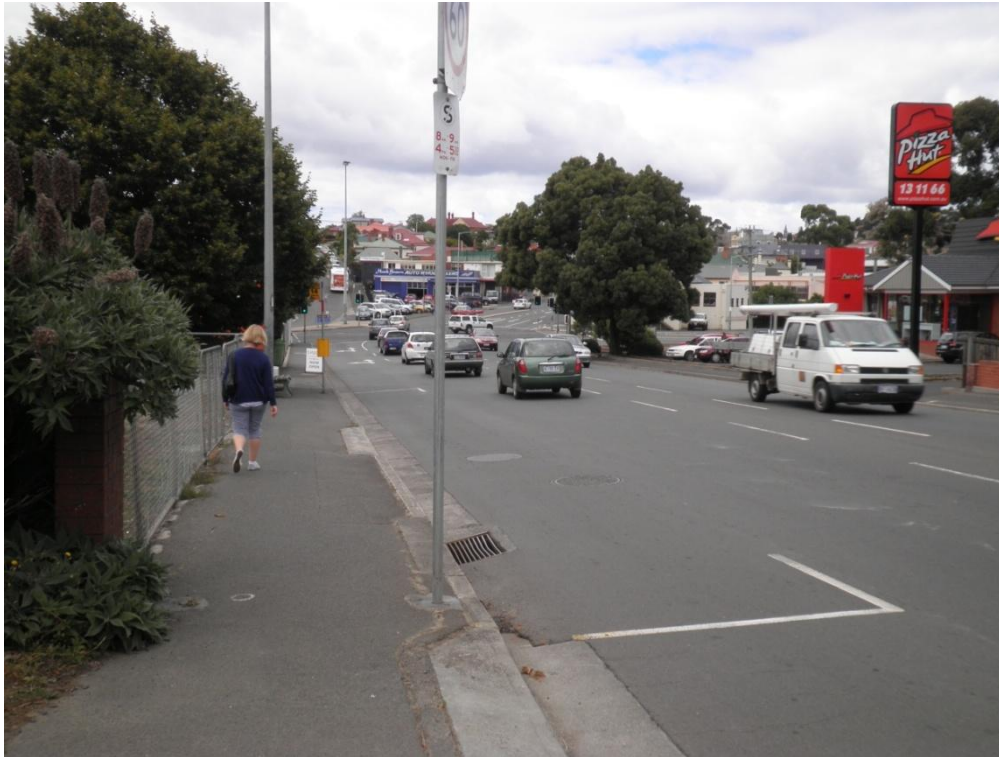
Figure 13 New Town – Inbound (Facing North)

Figure 14 New Town – Inbound (Facing South)

Characteristic	Description
Bus Stop	<ul style="list-style-type: none"> • static timetables • no route or locality maps are on display • approx. 200 m from New Town Plaza • located across from Pizza Hut • BWS and Hotel located on corner
Footpath	<ul style="list-style-type: none"> • asphalt • approx. 2 m wide • standard kerb • slight gradient
Pedestrian Crossings	<ul style="list-style-type: none"> • signalised pedestrian crossing approx. 30 m south of stop at the Risdon Road intersection
Safety	<ul style="list-style-type: none"> • high vehicle through traffic • low pedestrian traffic for much of the day
Lighting	<ul style="list-style-type: none"> • illumination provided by street lighting
Seating	<ul style="list-style-type: none"> • 1 bench seat on the footpath facing the road • waiting passengers could rest against a low concrete wall

Characteristic	Description
Visibility	<ul style="list-style-type: none">• bus stop sign is just visible from the intersection• street signage and some landmark information at intersection• view of oncoming buses is good due to straight road alignment

- ▶ There is limited space on the footpath due to the bus stop post, bin and bench all grouped together in one section of the footpath;
- ▶ View of approaching traffic is obstructed temporarily by buses for vehicles entering or exiting the bottle shop / hotel driveway;
- ▶ There is no shelter available; and
- ▶ It may be hard to find the stop from New Town Plaza, although once at the intersection the bus stop can be seen.

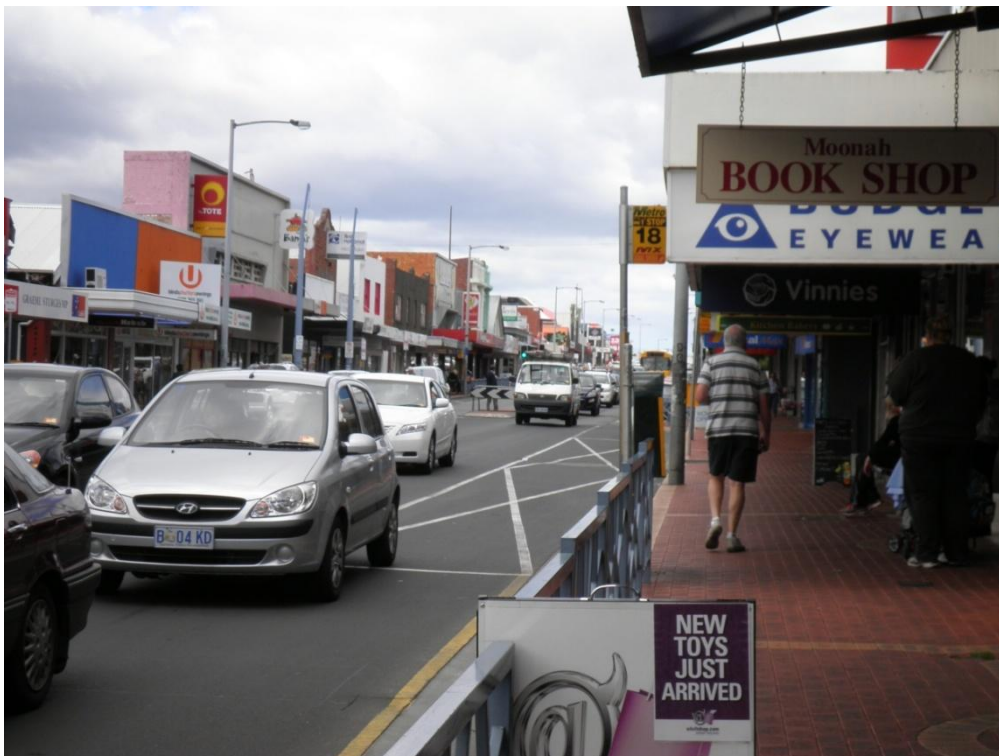
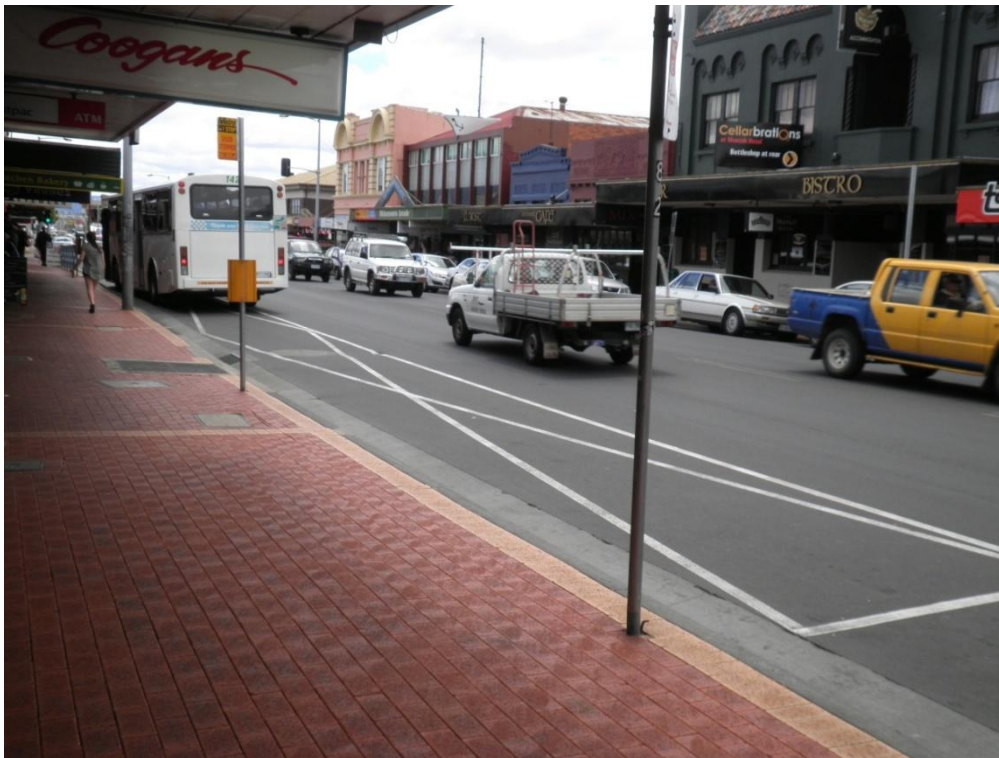
Figure 15 Moonah – Outbound (Facing North)

Figure 16 Moonah – Outbound (Facing South)

Characteristic	Description
Bus Stop	<ul style="list-style-type: none"> • static timetables • no route or locality maps are on display
Footpath	<ul style="list-style-type: none"> • paved • approx. 3 m wide • standard kerb • no tactile surface indicators
Pedestrian Crossings	<ul style="list-style-type: none"> • close to signalised pedestrian crossing
Safety	<ul style="list-style-type: none"> • shops, restaurants and bars in close proximity to the stop creating high pedestrian traffic • high vehicle through traffic
Lighting	<ul style="list-style-type: none"> • illumination provided by street lighting
Pay phone	<ul style="list-style-type: none"> • phone box located across the road
Shelter	<ul style="list-style-type: none"> • provided by shop awnings
Seating	<ul style="list-style-type: none"> • 1 bench seat facing road on the footpath

Characteristic	Description
Bike storage	<ul style="list-style-type: none">• bike hoops nearby
Access	<ul style="list-style-type: none">• continuity and connectivity is good• stop located centrally in Moonah just before intersection so passengers can use signalised pedestrian crossings
Visibility	<ul style="list-style-type: none">• good view of oncoming buses

- ▶ Waiting passengers causes slight congestion with through pedestrian traffic, although the footpath is relatively wide;
- ▶ A second bus may not be able to stop completely parallel to kerb due to vehicle parking in the loading zone behind the bus stop.

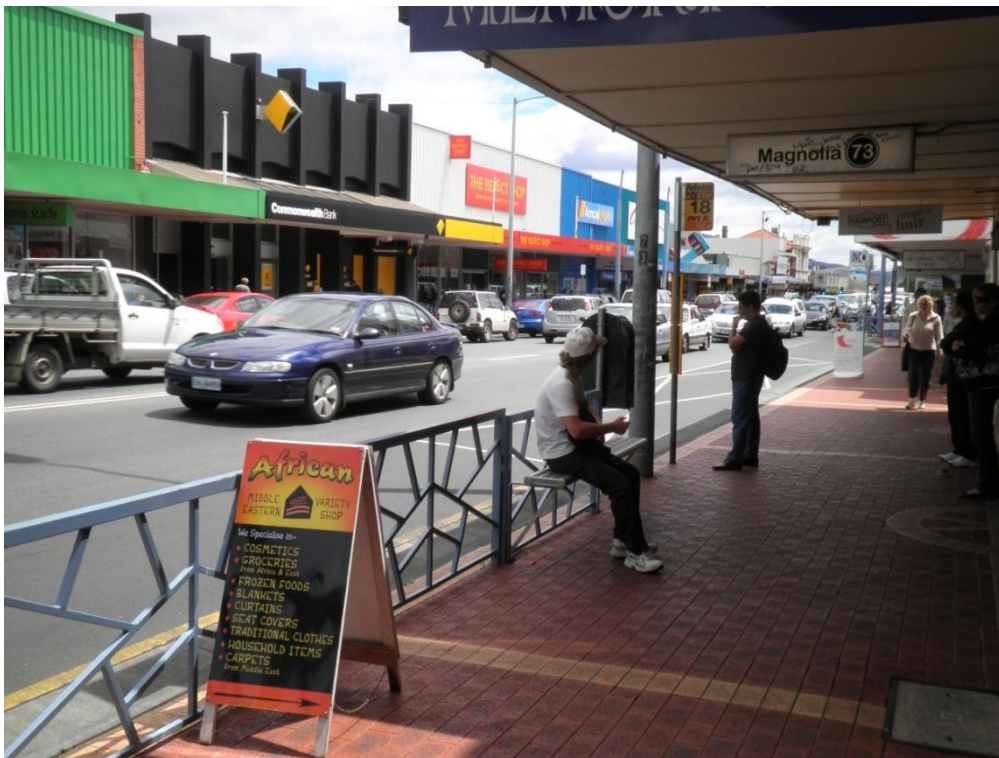
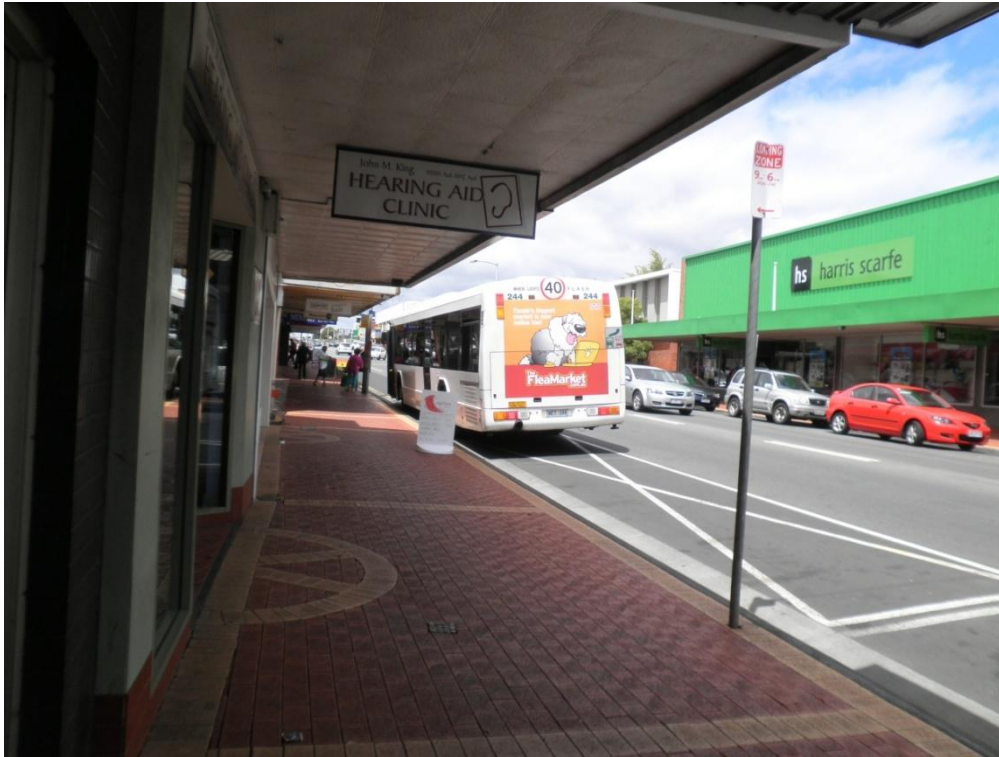
Figure 17 Moonah – Inbound (Facing North)

Figure 18 Moonah – Inbound (Facing South)

Characteristic	Description
Bus Stop	<ul style="list-style-type: none"> static timetables no route or locality maps are on display
Footpath	<ul style="list-style-type: none"> paved approx. 3.5 m wide standard kerb surface level no tactile surface indicators
Pedestrian Crossings	<ul style="list-style-type: none"> stop located centrally in Moonah just before and intersection so passengers can use the signalised pedestrian crossings
Safety	<ul style="list-style-type: none"> high pedestrian traffic
Traffic	<ul style="list-style-type: none"> high vehicle through traffic
Lighting	<ul style="list-style-type: none"> illumination provided by street lighting
Pay phones	<ul style="list-style-type: none"> located across the road at Post Office
Shelter	<ul style="list-style-type: none"> shelter provided by shop awnings

Characteristic	Description
Seating	<ul style="list-style-type: none">• 1 bench seat facing the buildings on the kerb side of the footpath
Access	<ul style="list-style-type: none">• close to shops and Commonwealth Bank• continuity and connectivity to surrounds good with a stop located centrally in Moonah
Sight distance	<ul style="list-style-type: none">• good view of oncoming buses

- ▶ Passengers waiting, lean against shop walls which causes slight congestion with pedestrian through traffic; and
- ▶ Limited seating capacity.

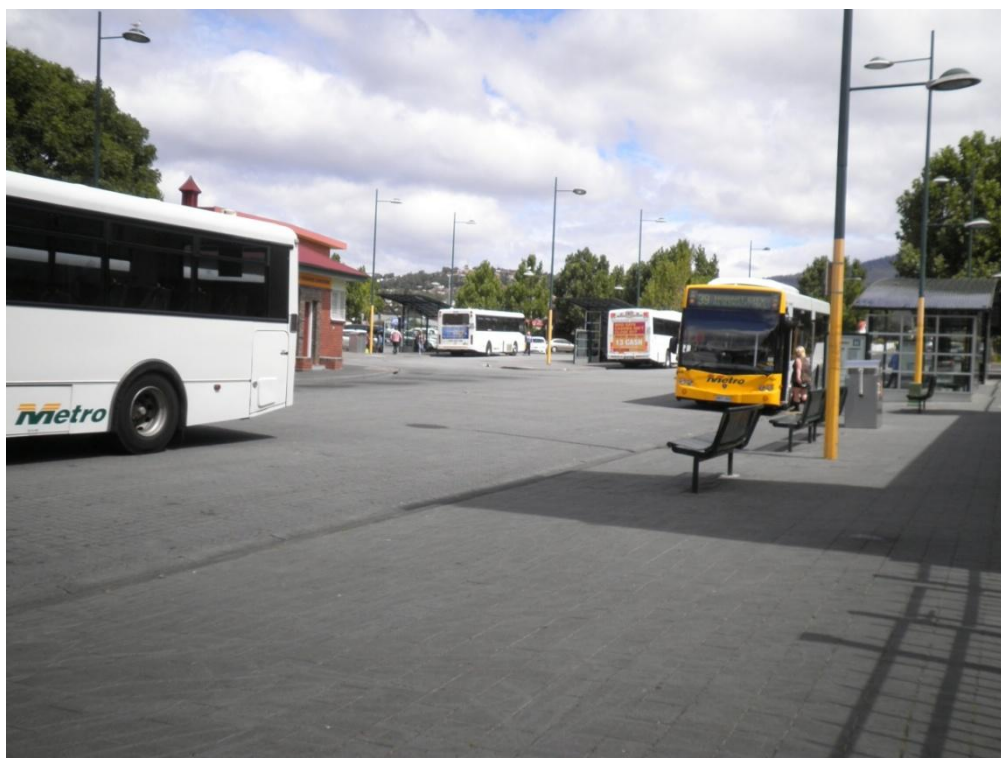
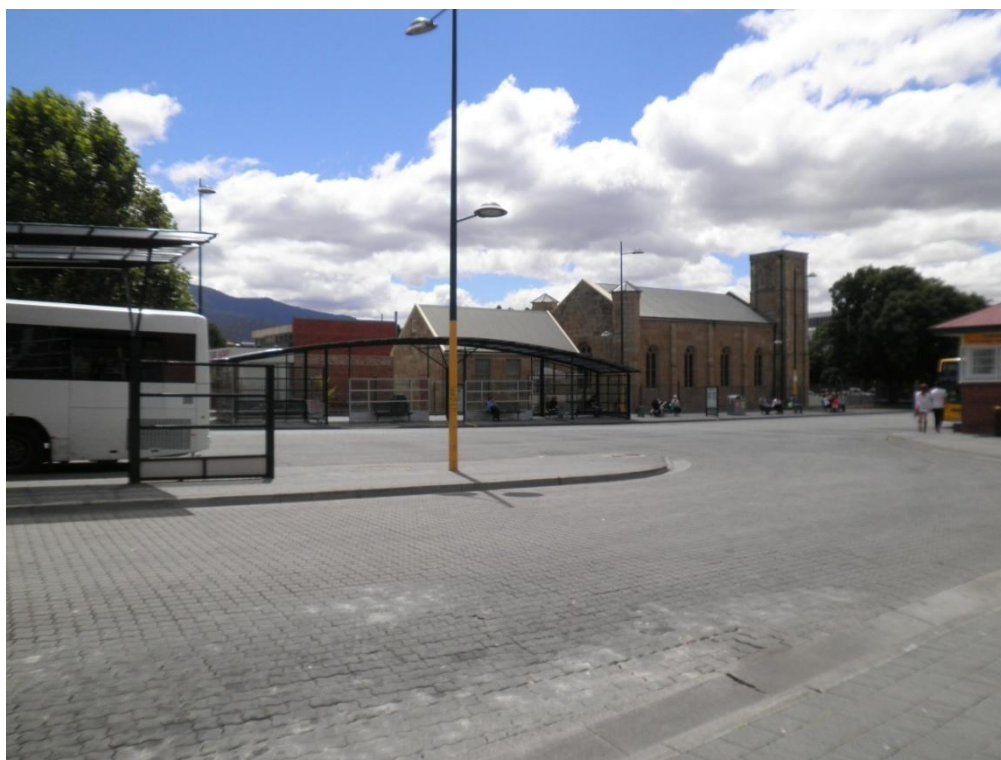
Figure 19 Glenorchy – Inbound (Facing South)

Figure 20 Glenorchy – Inbound (Facing West)

Characteristic	Description
Bus Stop	<ul style="list-style-type: none"> • static timetables • some route or locality maps are on display
Footpath	<ul style="list-style-type: none"> • paved • approx. 4 m wide • standard kerb • surface is level • no tactile surface indicators
Pedestrian Crossings	<ul style="list-style-type: none"> • signalised crossings present at the intersection at both ends of the bus interchange
Safety	<ul style="list-style-type: none"> • no CCTV cameras at stop • majority of pedestrian activity is from passenger waiting for buses
Lighting	<ul style="list-style-type: none"> • illumination provided by street lighting
Pay phones	<ul style="list-style-type: none"> • within 35m of the inbound stop
Public toilets	<ul style="list-style-type: none"> • within 20m of the outbound stop
Shelter	<ul style="list-style-type: none"> • shelter provided

Characteristic	Description
Seating	<ul style="list-style-type: none">• 2 benches under shelter• unsheltered bench seating available
Access	<ul style="list-style-type: none">• no dedicated drop off zones or parking for kiss and ride or park and ride are provided• there is a car park adjacent car park that could be used for short-term parking
Visibility	<ul style="list-style-type: none">• good• oncoming buses can be seen turning into interchange from Main Road

- ▶ There is limited passive security at the stop as pedestrian traffic is mainly comprised of waiting passengers;
- ▶ Only limited bus route maps are available and there is a lack of locality maps;
- ▶ Way finding to the bus stop is limited as there are limited measures in terms of directing pedestrians to the bus interchange. There were no observed signs to help direct people from Main Road to the bus interchange; and
- ▶ There are no dedicated drop off zones or parking for kiss and ride or park and ride besides the Council car park adjacent to the stop with short term parking limits.

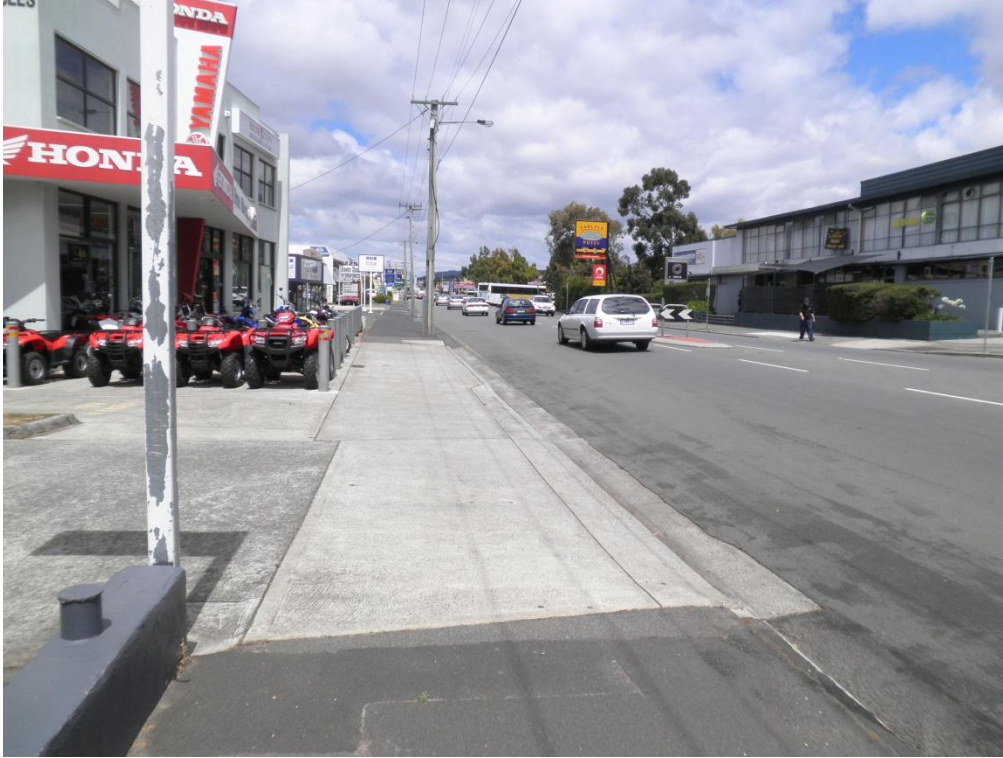
Description	Advantages	Disadvantages	Other Notes
Bus stop opposite Carlisle Hotel (see Figure 21)	<ul style="list-style-type: none"> Located clear of influence of signalised intersection Proximity to pedestrian refuge island 	<ul style="list-style-type: none"> Distance from Springfield interchange (park and ride) Potential for through traffic to be delayed due to inadequate lane width 2 buses may not be accommodated clear of driveways 	<ul style="list-style-type: none"> Would potentially consolidate with existing Johnson Street stop May be able to negotiate temporary obstruction of driveways by a bus to avoid closing them altogether
Bus stop opposite Springfield interchange (at start of left turn lane) (see Figure 22)	<ul style="list-style-type: none"> Minimise delays for bus travel times Reduce impact on intersection operation 	<ul style="list-style-type: none"> Driveway conflicts - 2 buses may not be accommodated clear of driveways. Power poles and road signs obstruct waiting area Buses may have difficulty re-entering through traffic lane Indirect pedestrian access to interchange May reduce capacity of left turn lane 	<ul style="list-style-type: none"> Additional pedestrian refuge island should be considered Alternative access to Totally Workwear (e.g. through Building Supplies access) could resolve driveway conflicts

Figure 21 Potential Bus Stop Location Opposite Carlisle Hotel

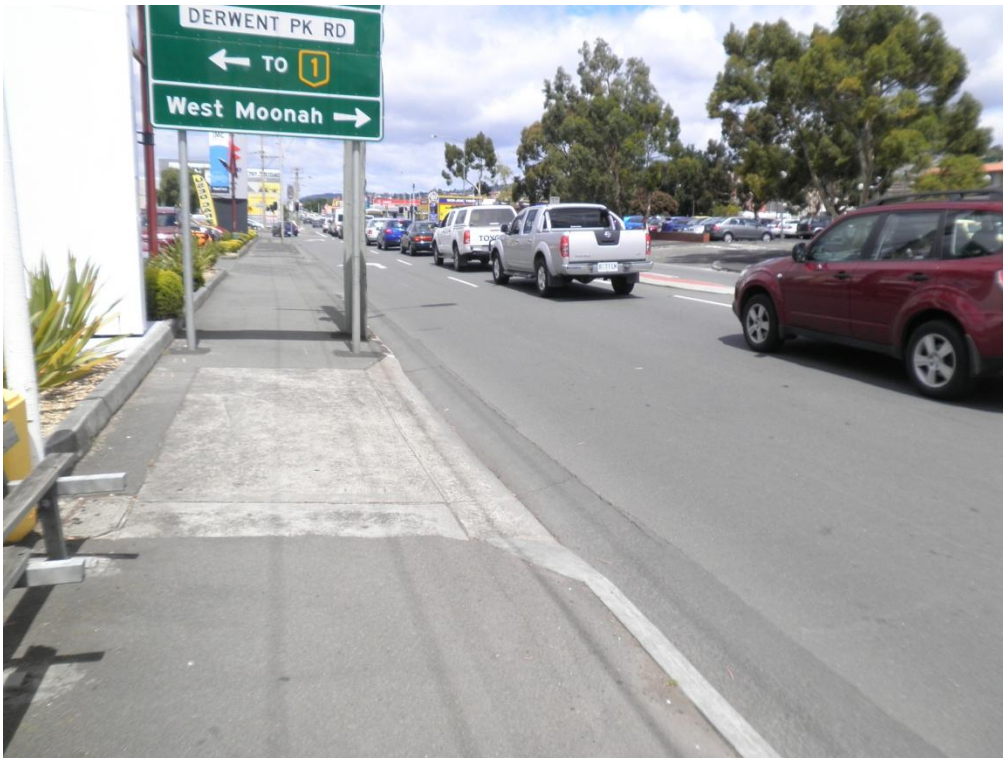
Neither of these options is without complications, and therefore no firm recommendation can be made at this stage. A fourth option which should be considered also is that the inbound stop remain at the Springfield interchange, and that bus priority measures be put in place to minimise the amount of delay experienced by buses turning right from Springfield Avenue into Main Road. Such measures could include the ability for approaching buses to extend or call early the right turn phase.

Figure 22 Potential Bus Stop Location Opposite Springfield Interchange

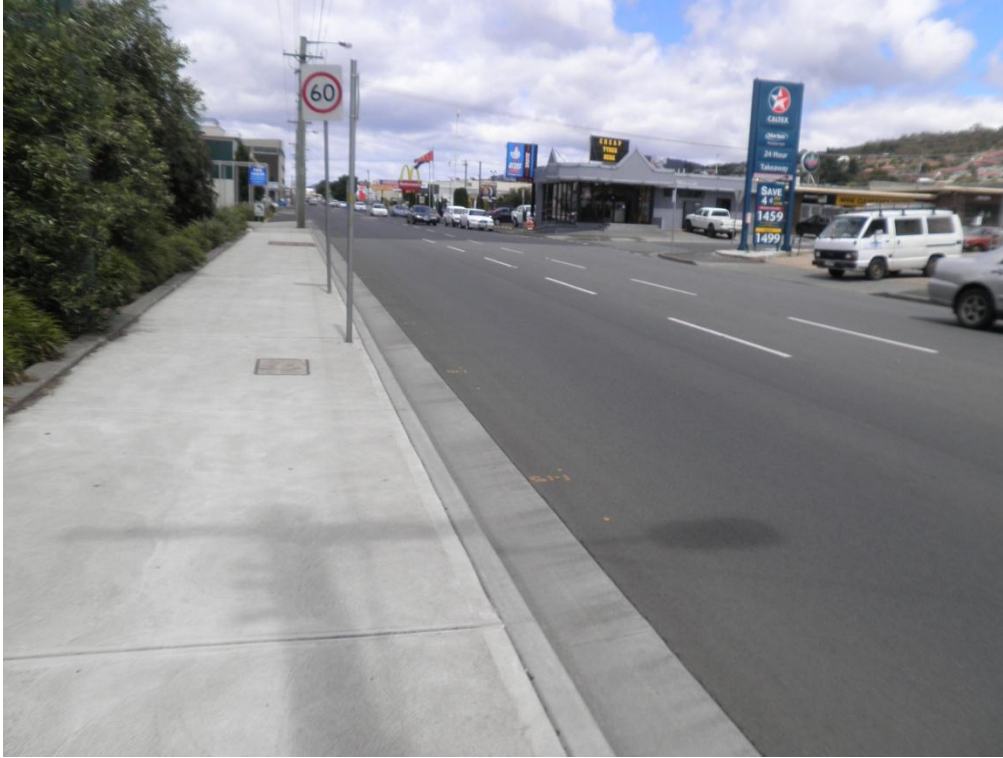
Bus stop opposite Bob Jane T-Mart (see Figure 23)	<ul style="list-style-type: none"> Minimise impact on intersection operation 	<ul style="list-style-type: none"> Traffic departing signalised intersection may be stopped by stationary bus Buses potentially delayed twice in vicinity of intersection Distance from Springfield interchange (park and ride) 	<ul style="list-style-type: none"> May be potential for reducing footpath width, but at expense of passenger facility space. In-ground services may also be an issue Would potentially consolidate with existing Maxwell Street stop

Figure 23 Potential Bus Stop Location Opposite Bob Jane T-Mart
