Tasmanian North East Rail Line

Assessment for Establishing a Heritage Rail Operation

Executive Summary

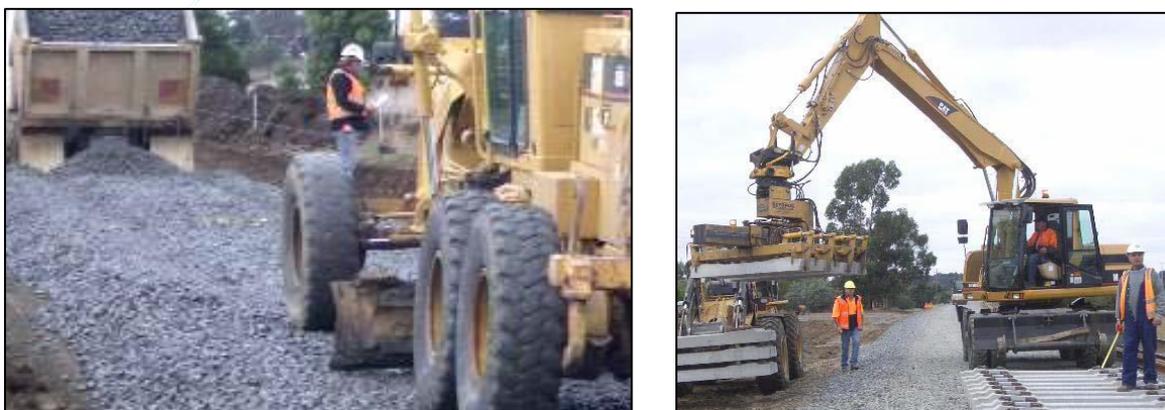
Figure 9. – Showing some of the work involved in rebuilding a level crossing

The picture on the left shows ballast unloaded onto the opened crossing and the picture on the right shows sleepers being bought in and placed on the ballast ready for the track to be laid.

The level crossing track reconstruction involves removing the road surface material and track then rebuilding the track and reinstating the road surface. Figure 9 depicts the type of work involved in rebuilding the crossings after it has been opened up.

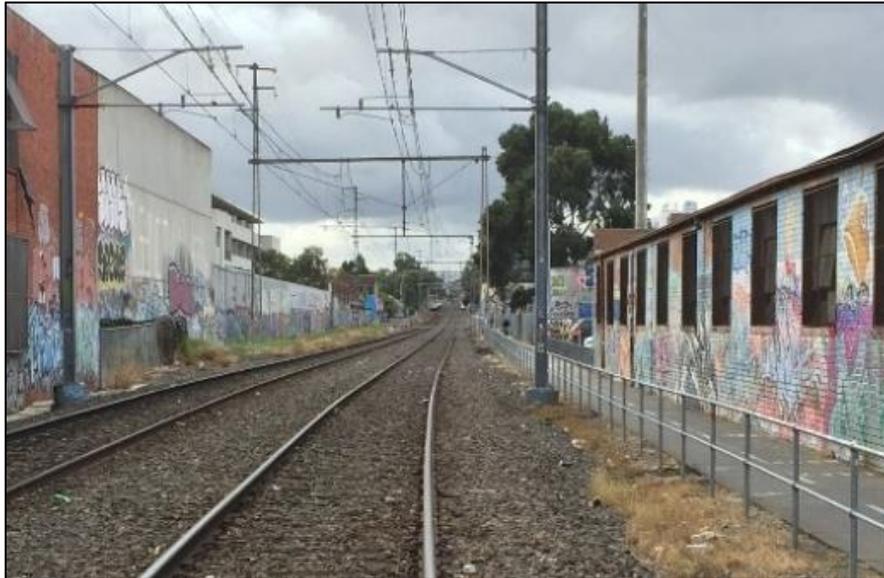
Figure 24. – Picture of Upfield line bike path in Victoria

Co-location of a bike path and an operating railway gives rise to the risk of bike path users straying on to the rail line and being hit by a train. The co-located bike path on the Upfield rail line in Victoria appears to have been successfully mitigated this risk by construction of a dividing fence. Figure 24 below shows a photo of the Upfield rail line and bike path with the dividing fence in place.
